Environmental Technology Resources, Inc.

August 20, 2018

Re: Asbestos Inspection Report, 1080 Murphy Avenue, Atlanta, Georgia

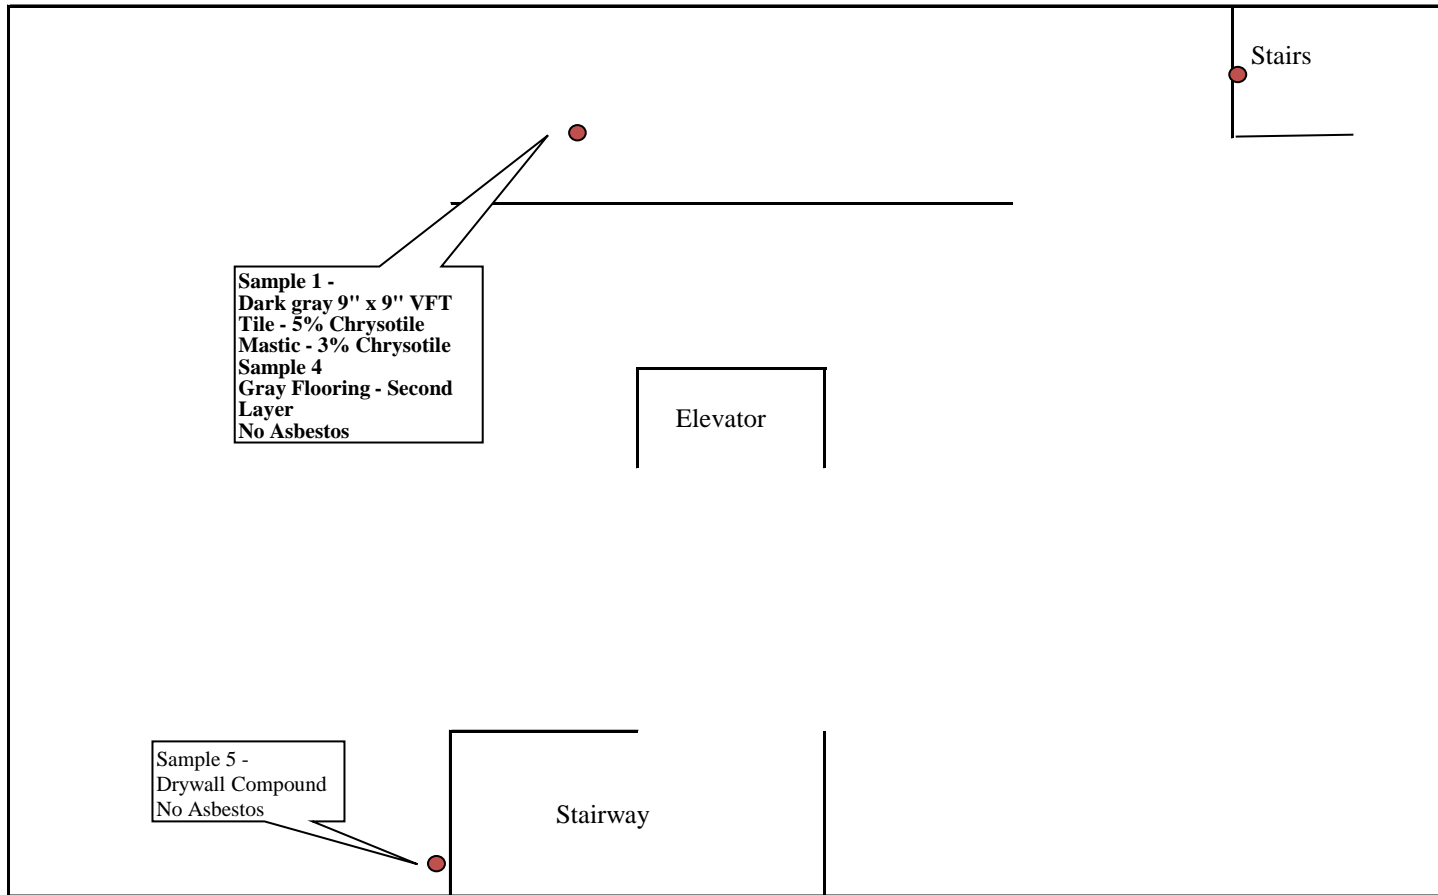
FIGURE 2
SUSPECT ASBESTOS CONTAINING MATERIALS
SAMPLE LOCATIONS - Second Floor
 1080 Murphy Avenue
 Atlanta, Georgia

<u>Sample I.D.</u>	<u>Description</u>	<u>Result</u>
Sample 1	Concrete Panel Walls Around Elevator	Layer 1 – 20% Chrysotile
Sample 4	Dark gray 9“ x 9” Vinyl Floor Tile – 2 nd Floor	Layer 1 Tile – 5% Chrysotile Layer 2 Mastic – 3% Chrysotile

Those materials that were found to contain asbestos should be removed and be properly disposed prior to conducting renovations or demolition of the building.
