Environmental Technology Resources, Inc.

September 8, 2020

Re: Lead-Based Paint Survey Report, 1088 and 1100 Murphy Avenue, Atlanta, Georgia

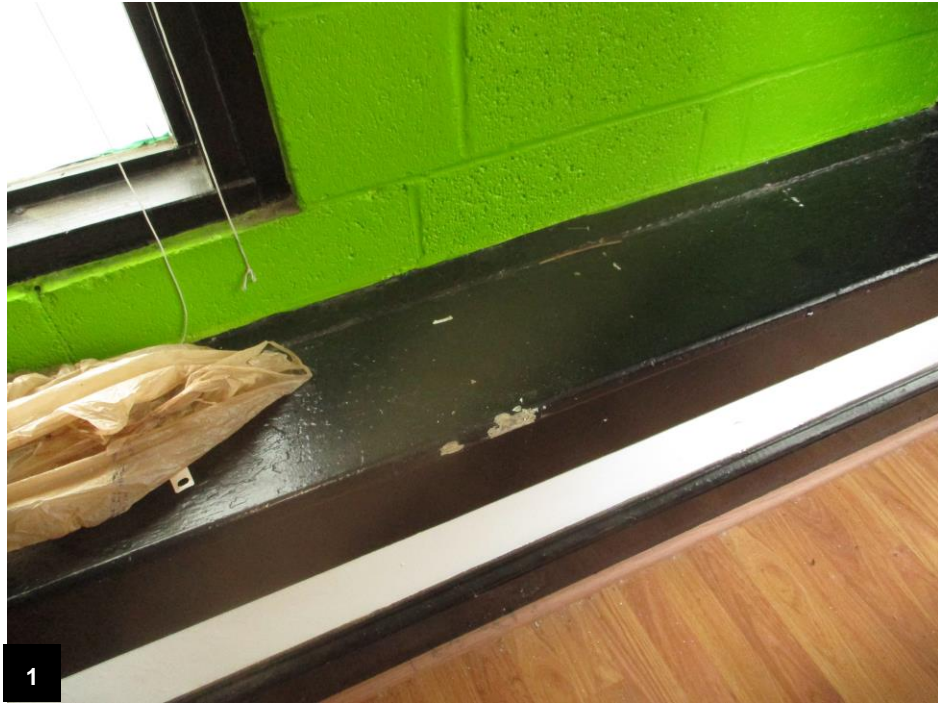
Sample 1 – Black Trim – 2nd Floor Office – 1100 Murphy Avenue
0.579 wt% Pb

Exposure to lead-based paint can be minimized by encapsulation, sealing or removal. The most appropriate method depends on the planned redevelopment of the buildings and future use.

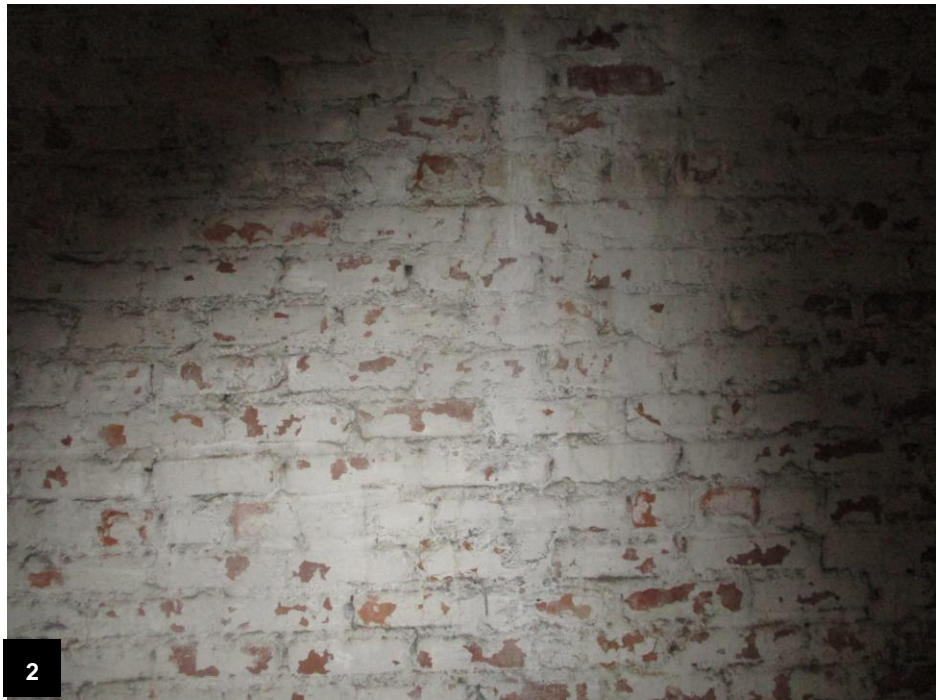
Sample 8 – White Paint on Brick – North Wall 3rd Floor – 1100 Murphy Avenue
1.10 wt% Pb

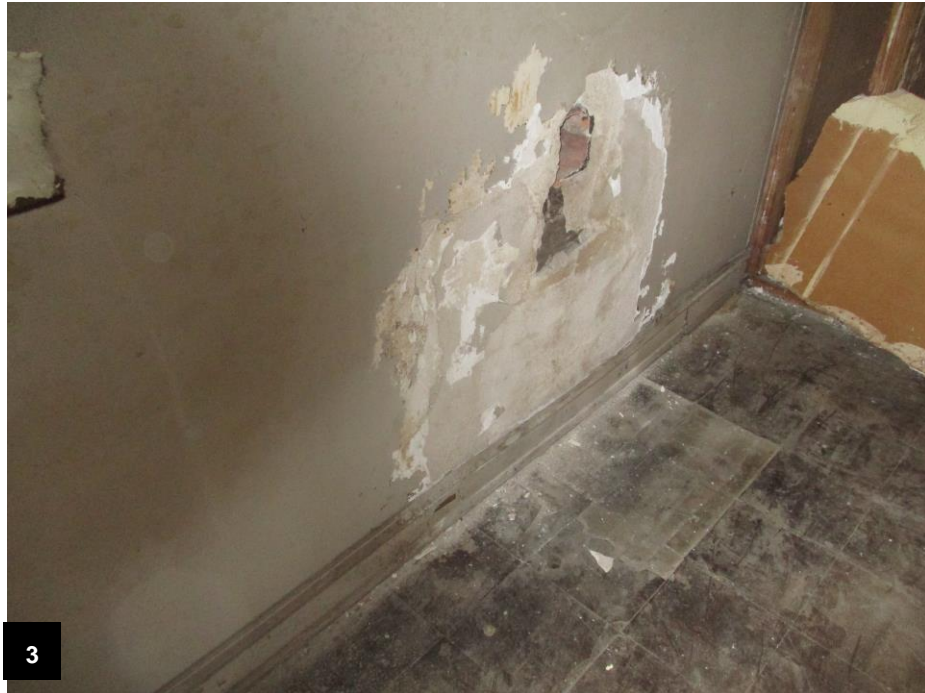
Sample 15 – Gray Wall Paint – North Wall 2nd Floor – 1088 Murphy Avenue
0.907 wt% Pb

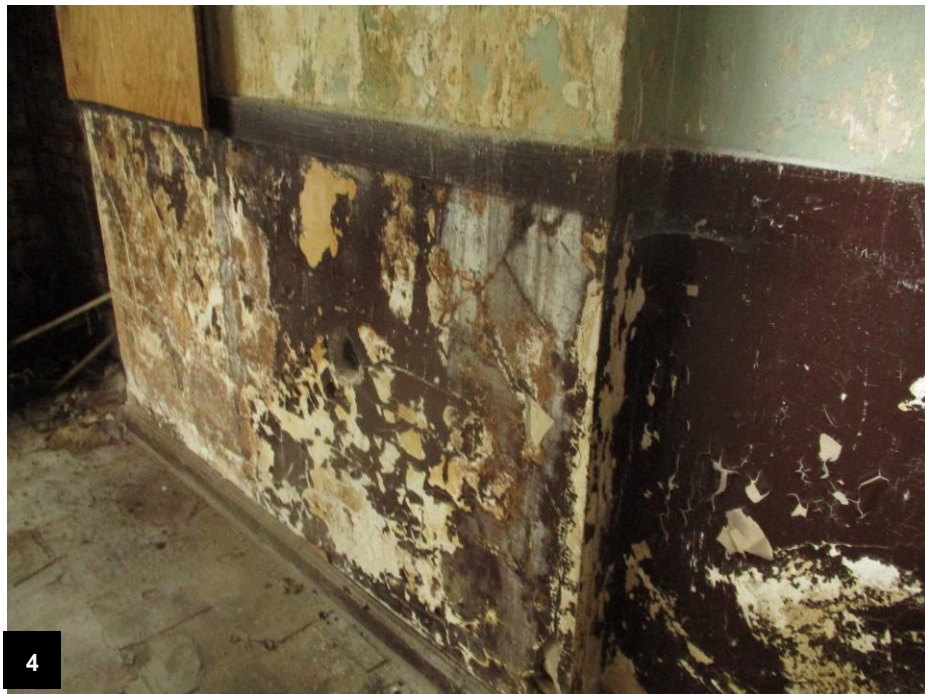
Sample 17 – Brown Wall Paint – North Wall 2nd Floor – 1088 Murphy Avenue
1.42 wt% Pb

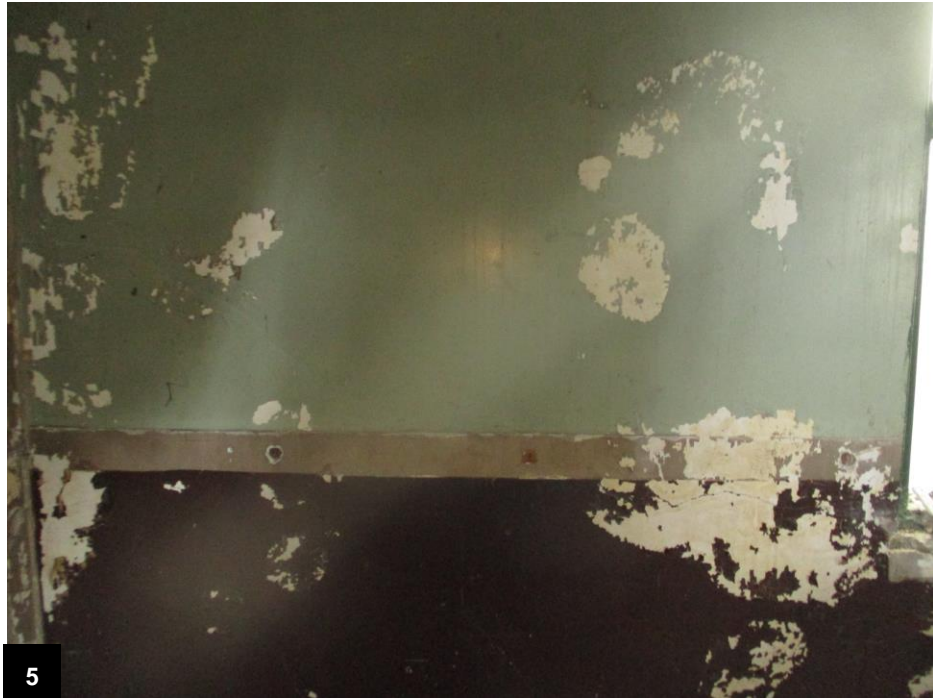
Sample 18 – Green Wall Paint – West Wall 2nd Floor – 1088 Murphy Avenue
0.89 wt% Pb

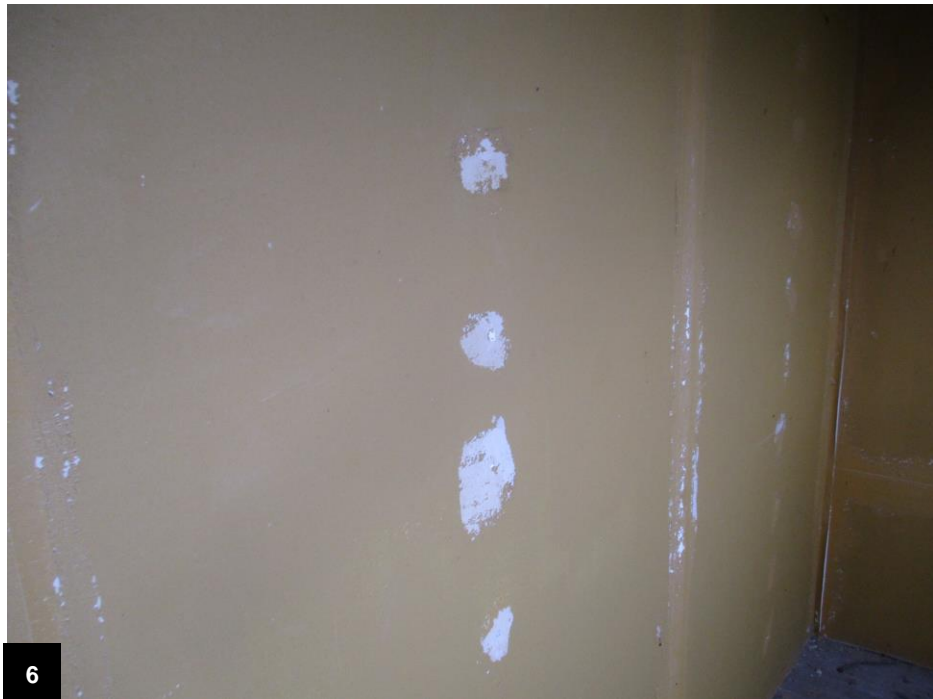
Sample 20 – Mustard Yellow Wall Paint – 3rd Floor Stairway – 1088 Murphy Avenue
8.75 wt% Pb
