**Environmental Technology Resources, Inc.**

August 20, 2018

Re: Asbestos Inspection Report, 1100 Murphy Avenue, Atlanta, Georgia

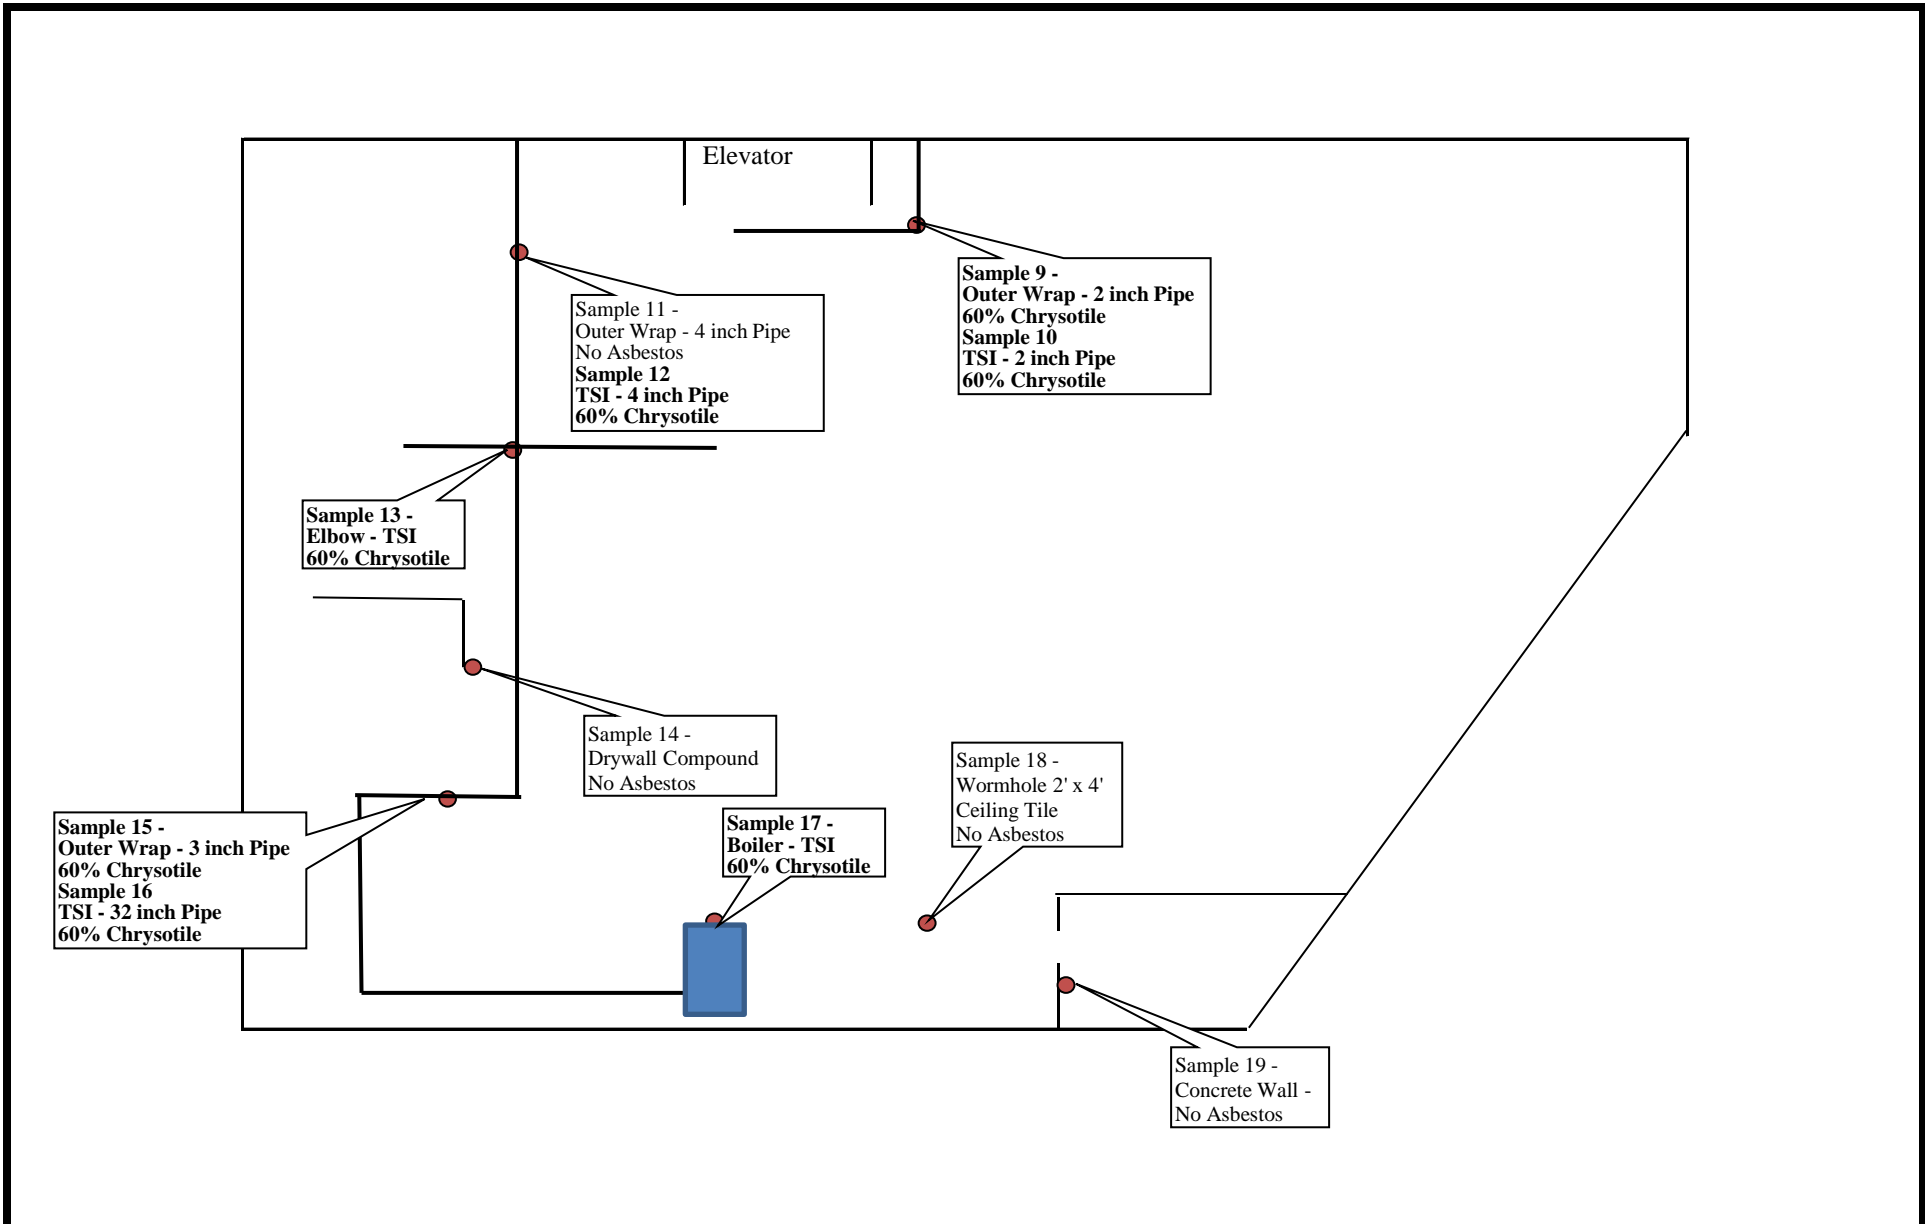
**FIGURE 1**  
**SUSPECT ASBESTOS CONTAINING MATERIALS**  
**SAMPLE LOCATIONS - First Floor**  
 1100 Murphy Avenue  
 Atlanta, Georgia

1st Floor	<b>Sample 9</b>	<b>Outer Wrap - 2 inch Pipe</b>	<b>Good, Non-friable</b>	<b>Layer 1 - 60% Chrysotile</b>
1st Floor	<b>Sample 10</b>	<b>Thermal System Insulation - 2 inch Pipe</b>	<b>Fair, Friable</b>	<b>Layer 1 - 60% Chrysotile</b>
1st Floor	Sample 11	Outer Wrap - 4 inch Pipe	Good, Non-friable	Layer 1 - No Asbestos
1st Floor	<b>Sample 12</b>	<b>Thermal System Insulation - 4 inch Pipe</b>	<b>Fair, Friable</b>	<b>Layer 1 - 60% Chrysotile</b>
1st Floor	<b>Sample 13</b>	<b>Elbow - TSI</b>	<b>Fair, Friable</b>	<b>Layer 1 - 30% Chrysotile</b>
1st Floor	Sample 14	Drywall Compound	Good, Non-friable	Layer 1 - No Asbestos
1st Floor	<b>Sample 15</b>	<b>Outer Wrap - 3 inch Pipe</b>	<b>Good, Non-friable</b>	<b>Layer 1 - No Asbestos</b> <b>Layer 2 - 60% Chrysotile</b>
1st Floor	<b>Sample 16</b>	<b>Thermal System Insulation - 3 inch Pipe</b>	<b>Fair, Friable</b>	<b>Layer 1 - 60% Chrysotile</b>
1st Floor	<b>Sample 17</b>	<b>Thermal System Insulation - Boiler</b>	<b>Fair, Friable</b>	<b>Layer 1 - 30% Chrysotile</b>

Those materials that were found to contain asbestos should be removed and be properly disposed prior to conducting renovations or demolition of the building.

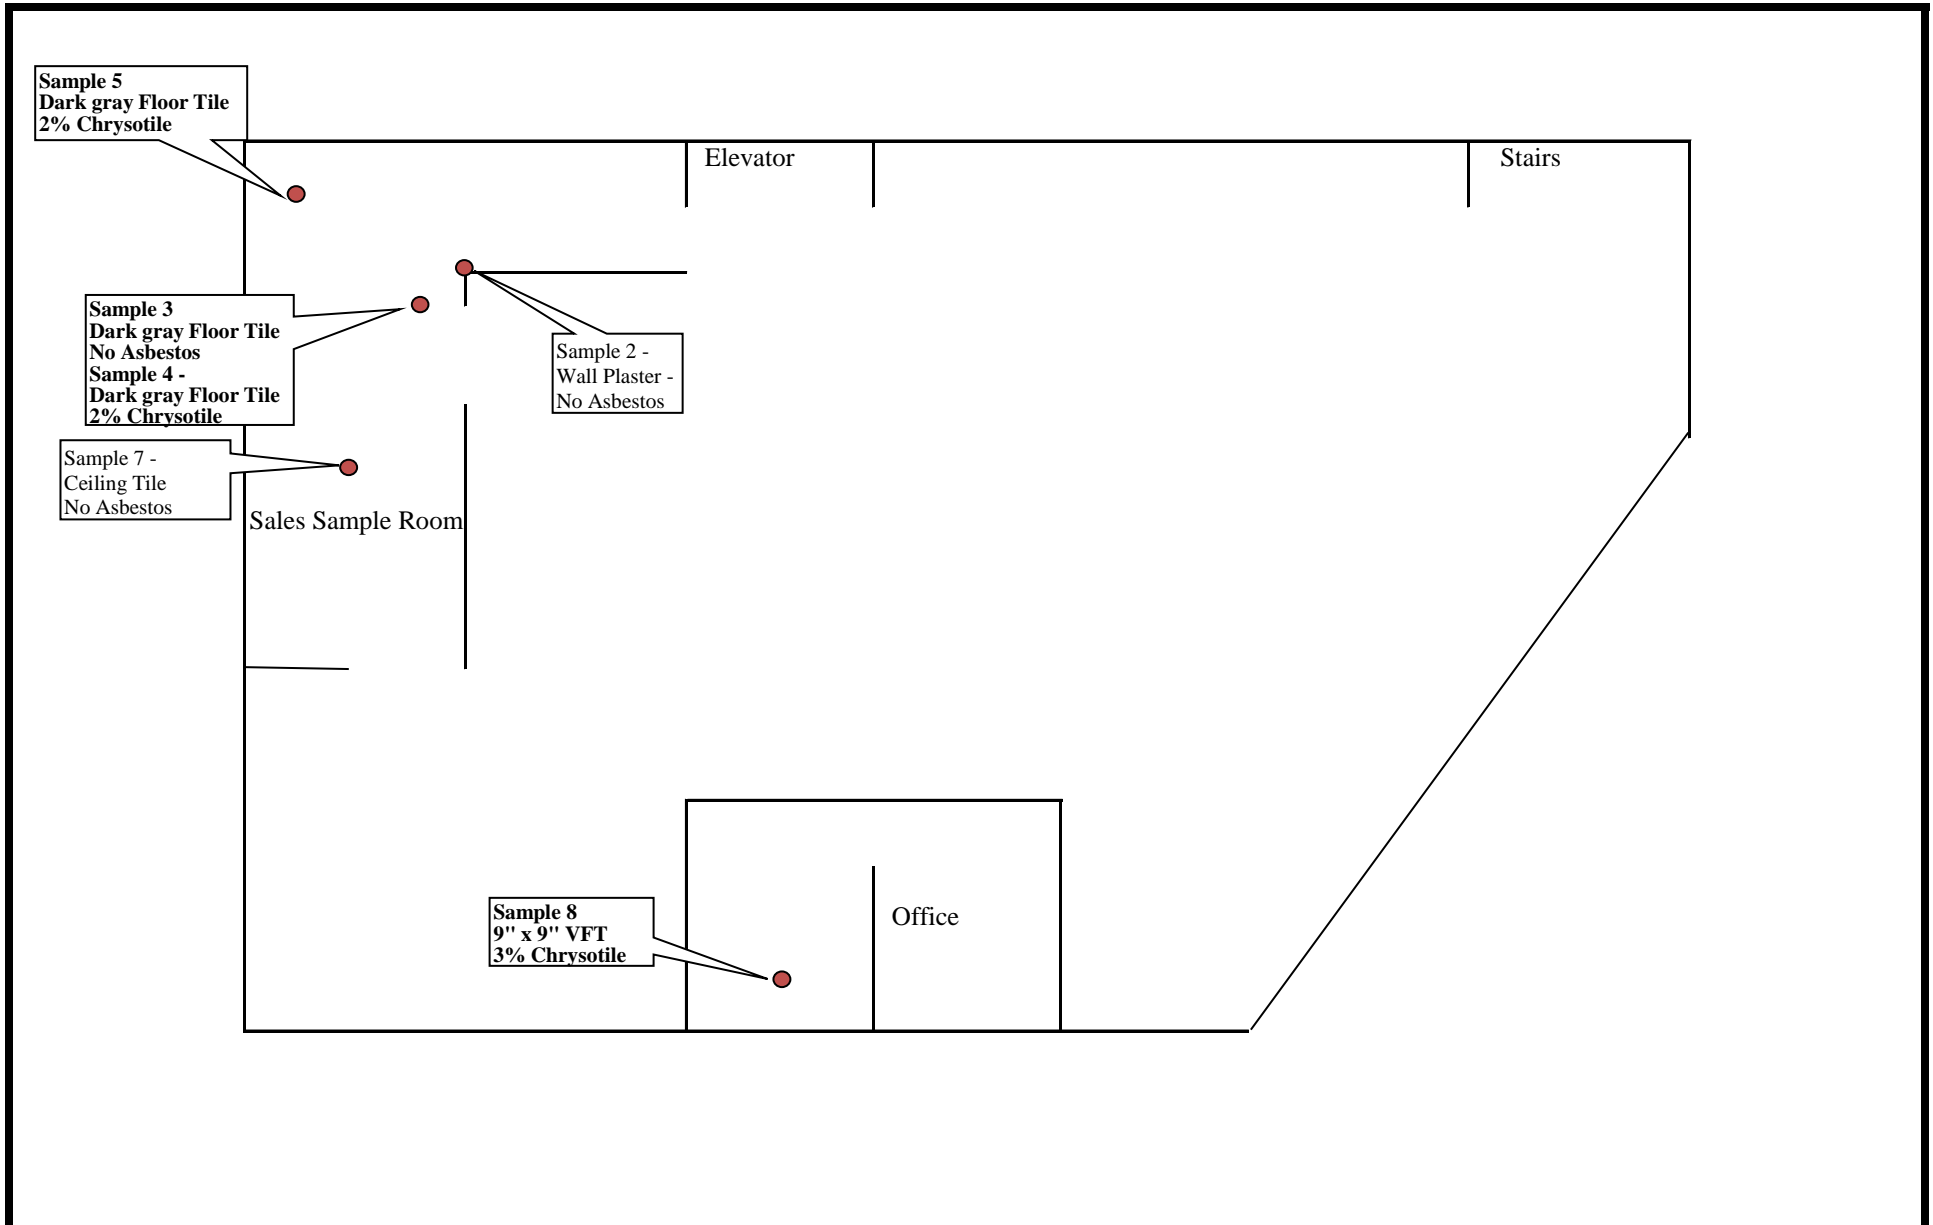
**FIGURE 2**  
**SUSPECT ASBESTOS CONTAINING MATERIALS**  
**SAMPLE LOCATIONS - Second Floor**  
 1100 Murphy Avenue  
 Atlanta, Georgia

<u>Sample I.D.</u>	<u>Description</u>	<u>Result</u>
Sample 4	Dark gray Vinyl Floor Tile – 2 <sup>nd</sup> Floor	Layer 1 Tile – 2% Chrysotile
Sample 5	Dark gray Vinyl Floor Tile – 2 <sup>nd</sup> Floor	Layer 1 Tile/Mastic – 2% Chrysotile
Sample 8	9 inch x 9 inch Vinyl Floor Tile – 2 <sup>nd</sup> Floor	Layer 1 Tile/Mastic – 3% Chrysotile
Sample 9	Outer Wrap – 2-inch Pipe	Layer 1 – 60% Chrysotile
Sample 10	Thermal System Insulation (TSI) – 2-inch Pipe	Layer 1 – 60% Chrysotile
Sample 12	Thermal System Insulation – 4-inch Pipe	Layer 1 – 60% Chrysotile
Sample 13	Elbow – TSI	Layer 1 – 30% Chrysotile
Sample 15	Outer Wrap – 3-inch Pipe	Layer 2 – 60% Chrysotile
Sample 16	Thermal System Insulation – 3-inch Pipe	Layer 1 – 60% Chrysotile
Sample 17	Thermal System Insulation – Boiler	Layer 1 – 30% Chrysotile
