LORD AECK SARGENT | A KATERRA COMPANY

# CONDITION ASSESSMENT

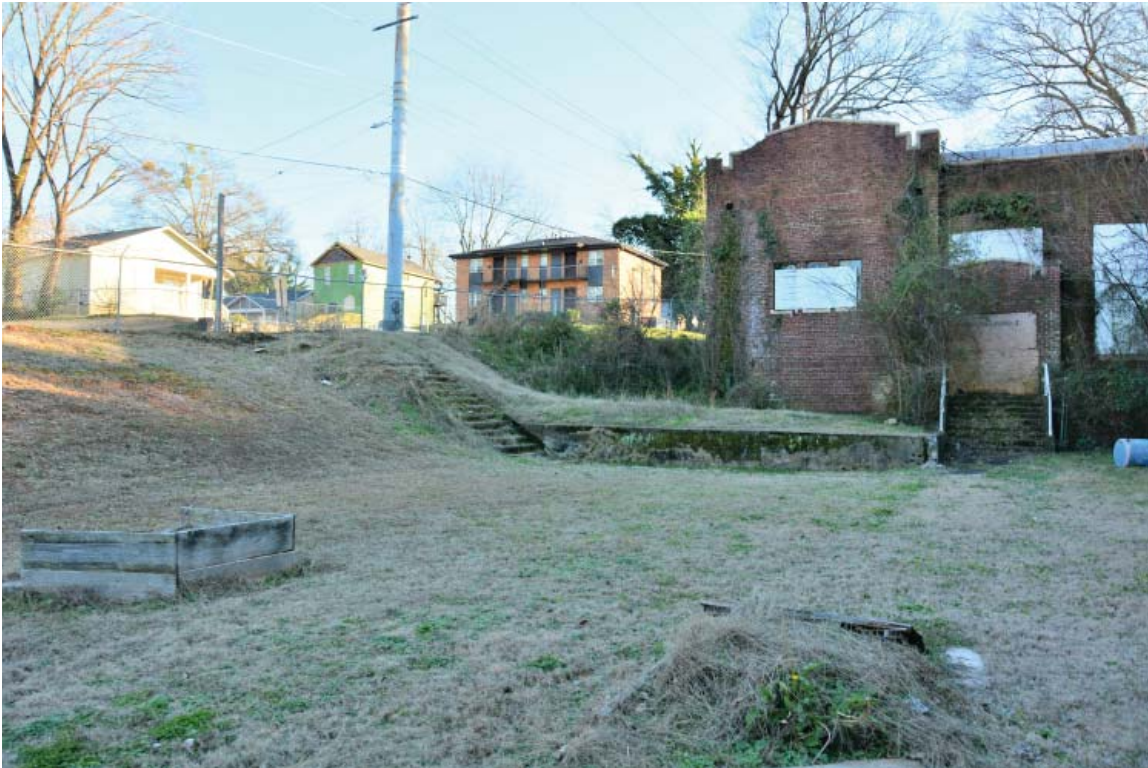
Figure 4. East Site Photo

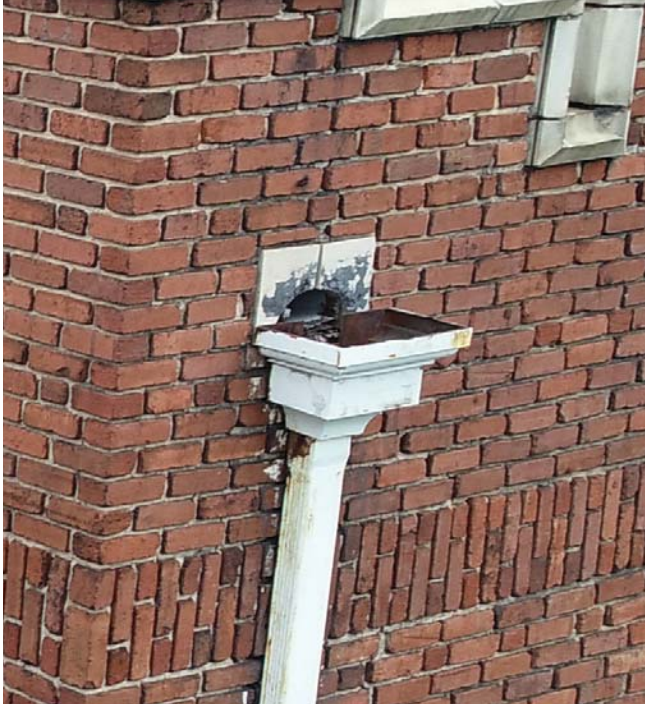
Figure 16. Scupper, collector head, and downspout on the 1911 portion of the building.

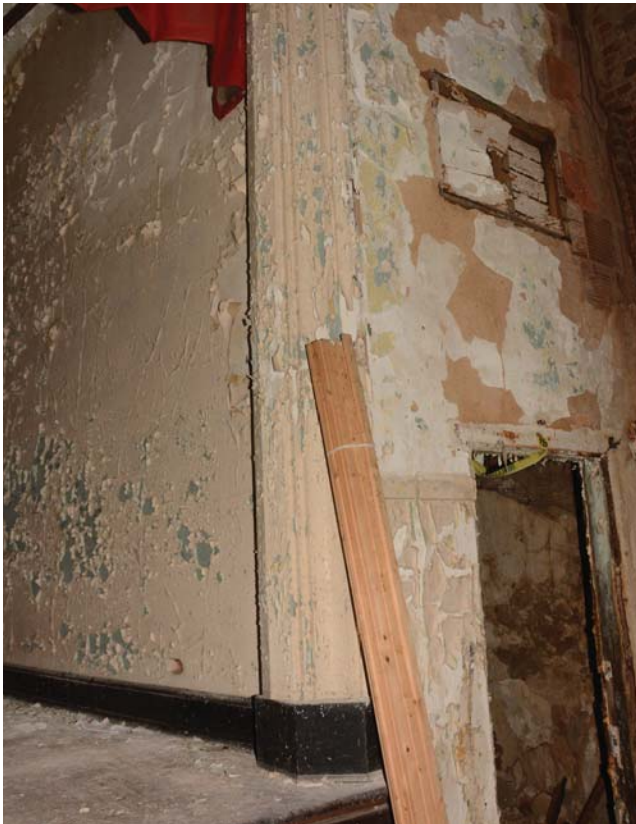
Figure 19. Detail of proscenium arch.

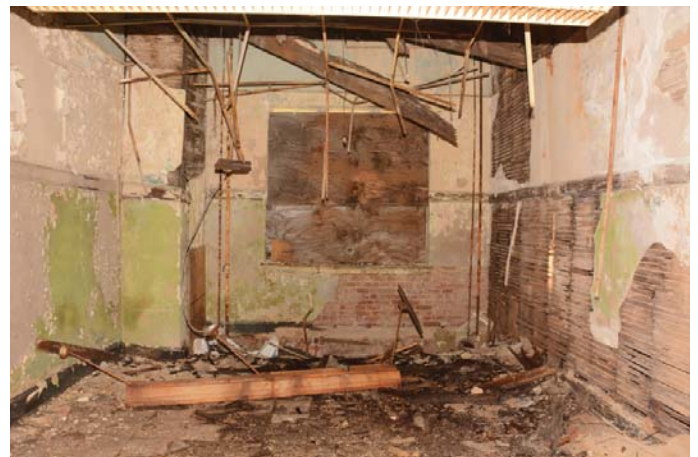
Figure 22. A more typical wall and plaster condition found in the 1911 section.

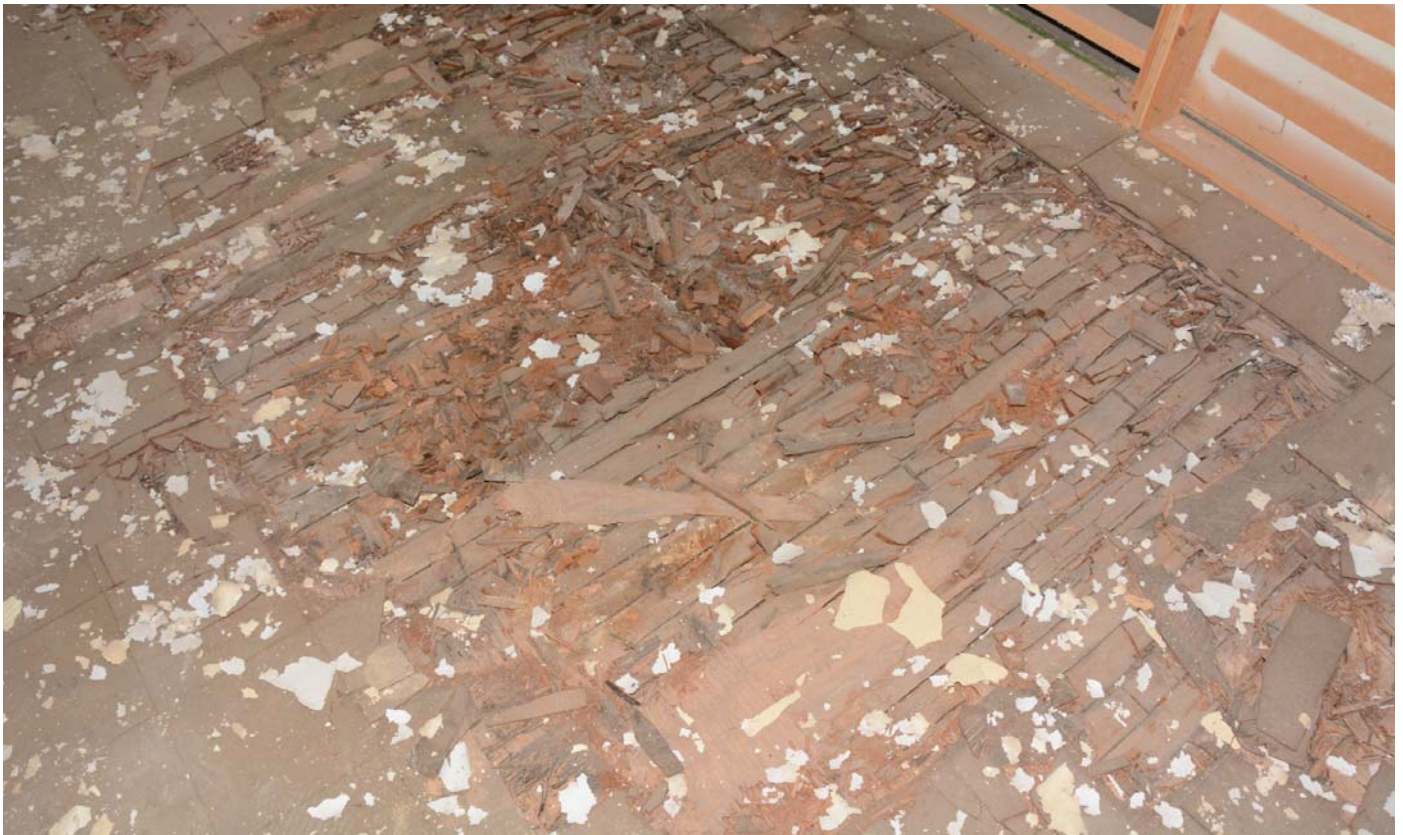
Figure 23. Detail of flooring showing highly deteriorated tongue and groove wood flooring that was below plywood, 9x9 VAT, and 12x12 resilient tile.

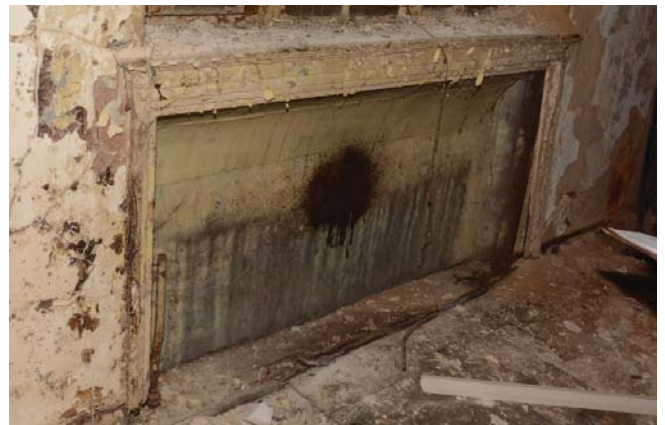
Figure 40. Radiator recess in Auditorium.

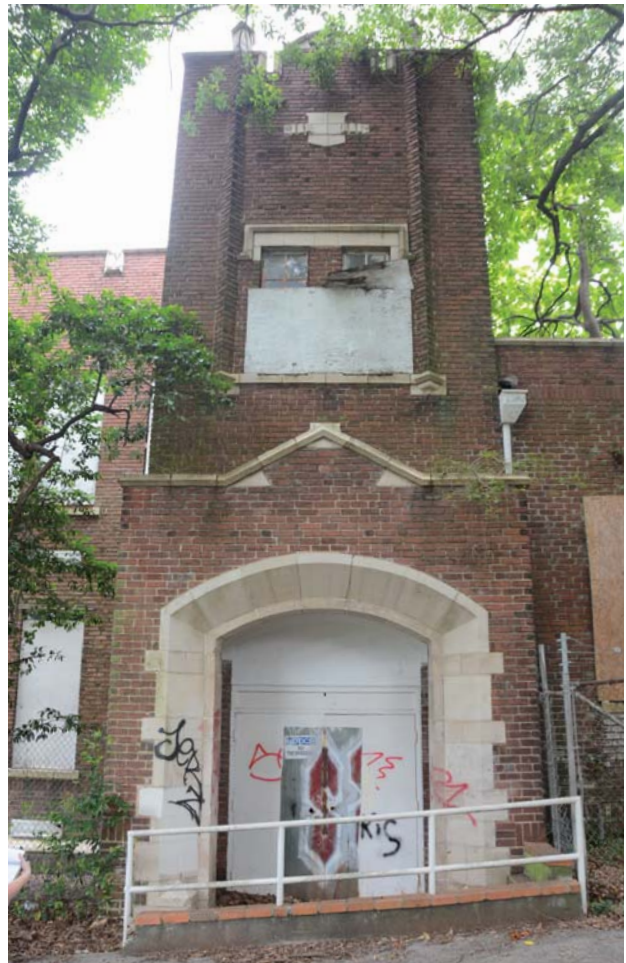
Figure 41. Pelham Street entrance.

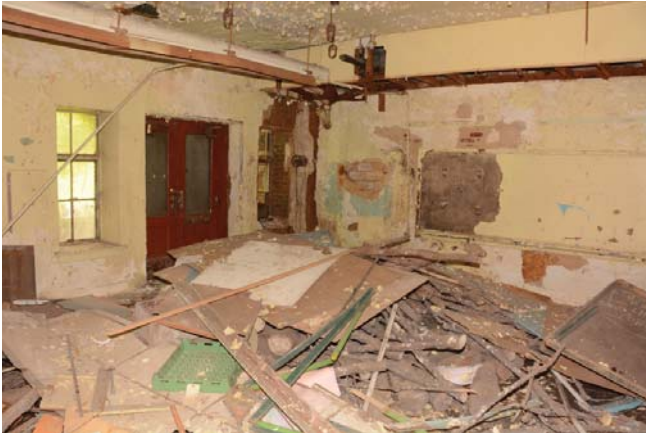
Figure 42. Debris piled up in a basement room.

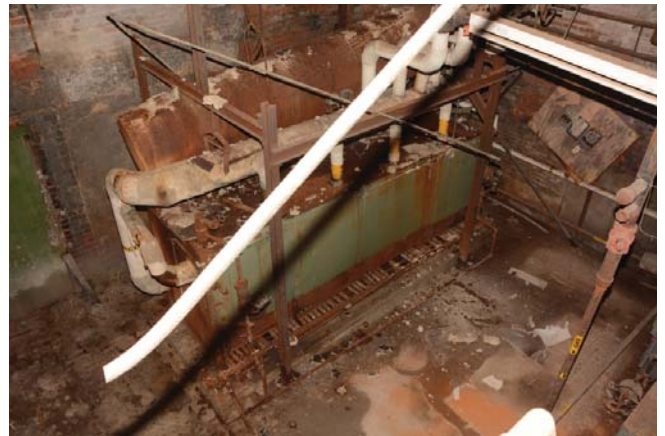
Figure 43. Some standing water was observed in the mechanical sub-basement.

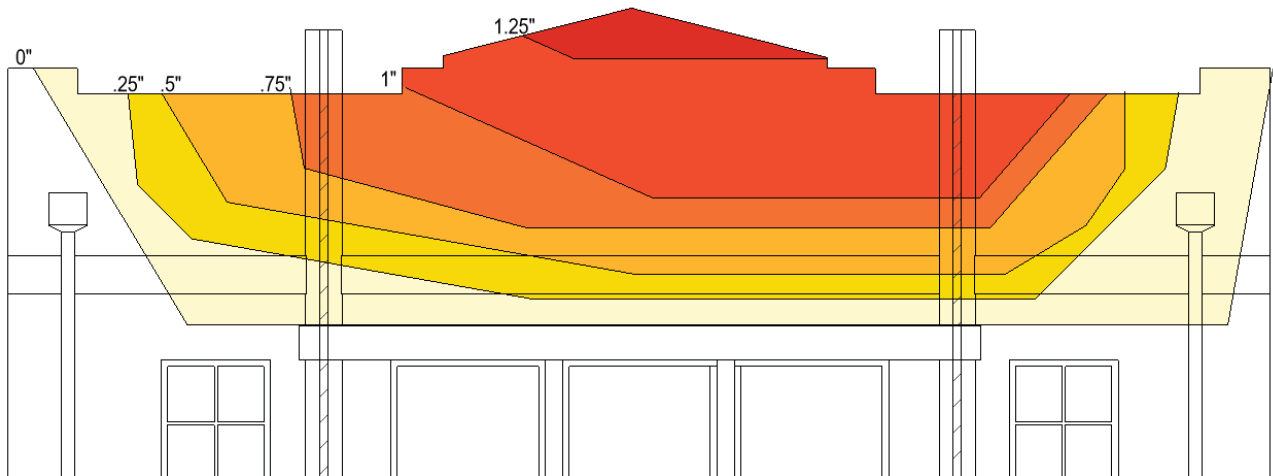
Figure 44. A heat map of the west gable wall showing the degree to which the masonry is out of plumb.

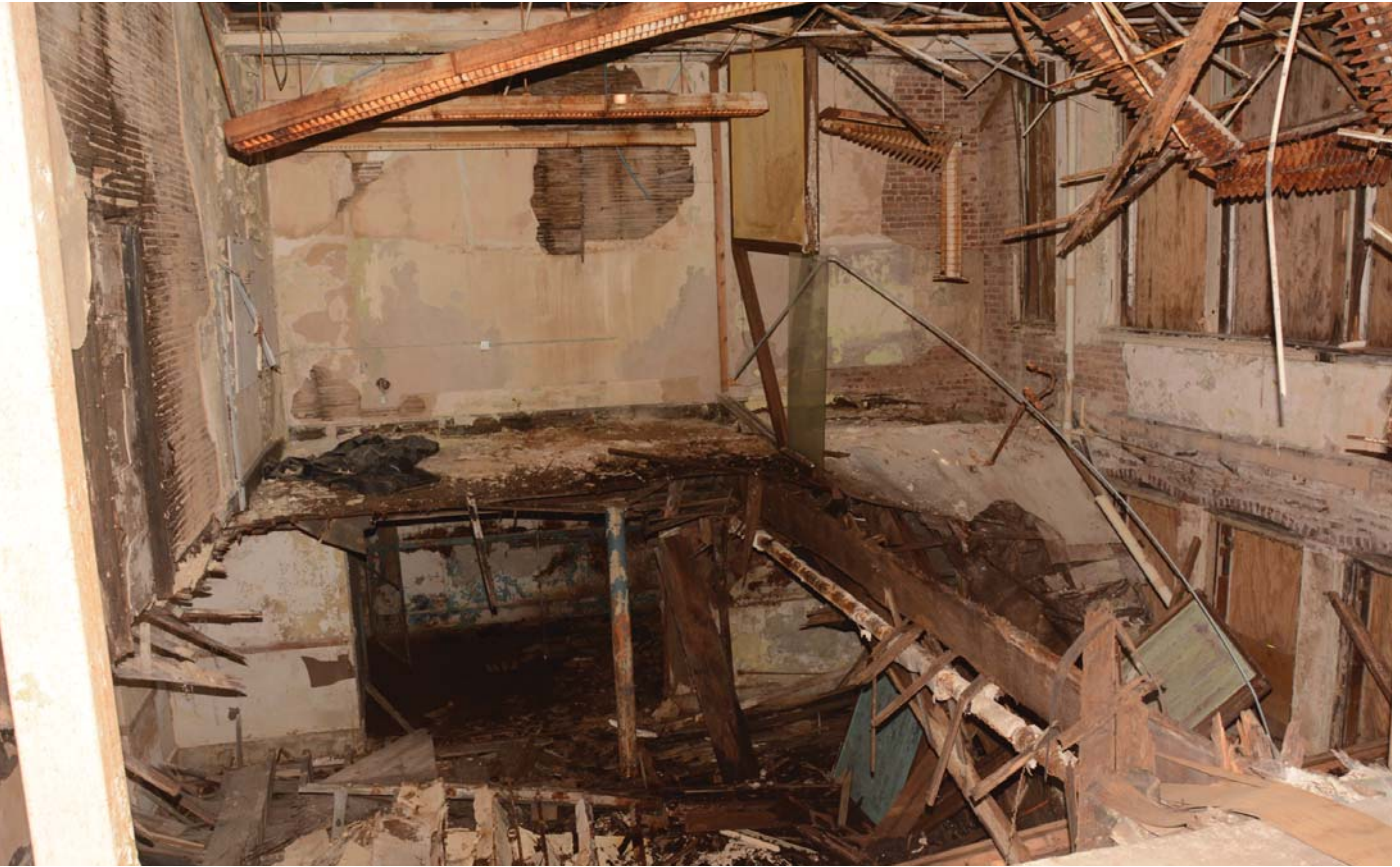
Figure 45. Wood Framing structural failure, Image also shows supplemental steel beam and column.

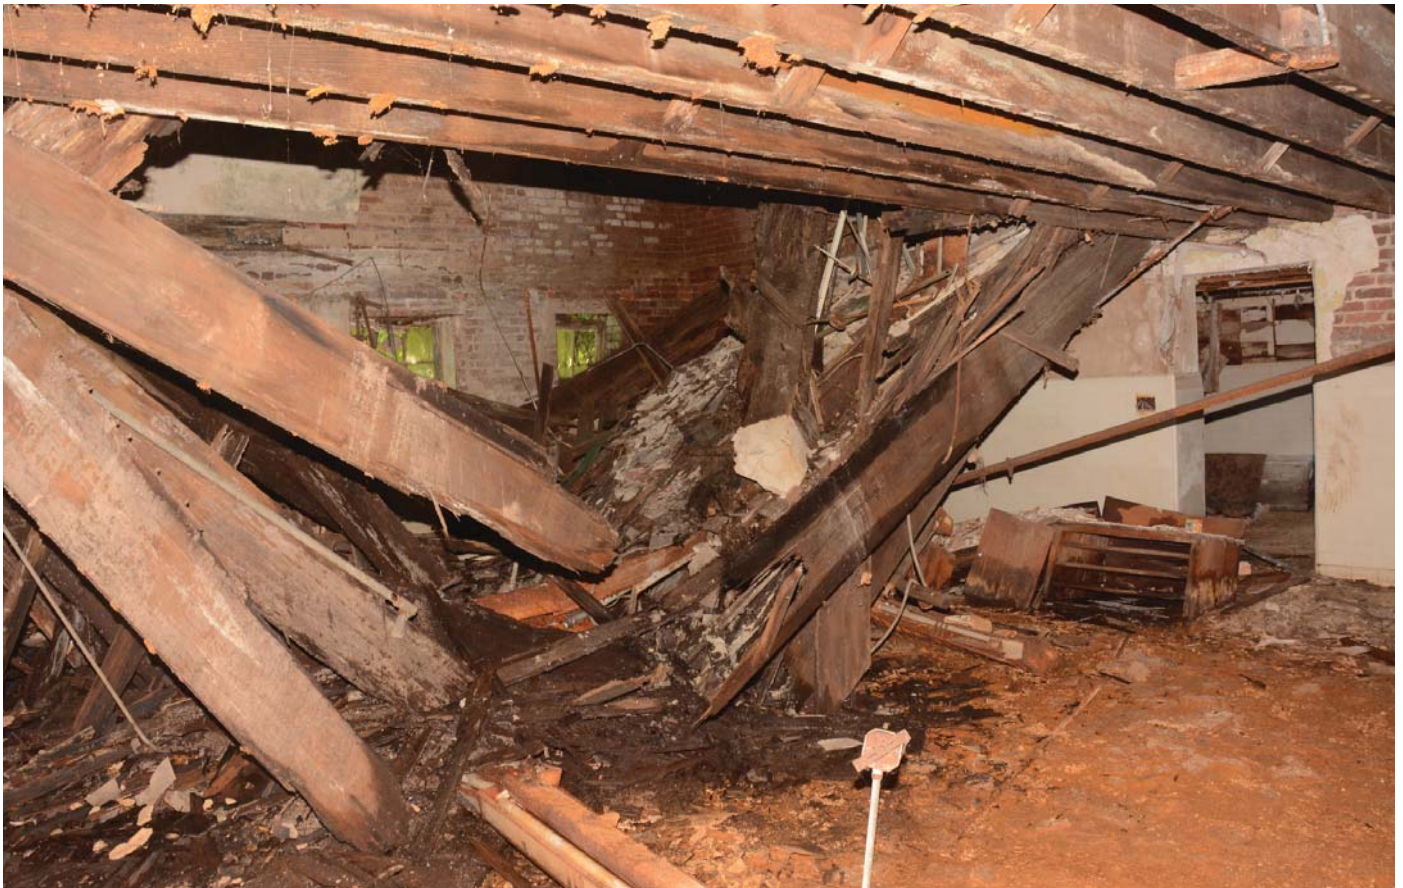
Figure 46. Unfortunately typical condition of the wood joists.

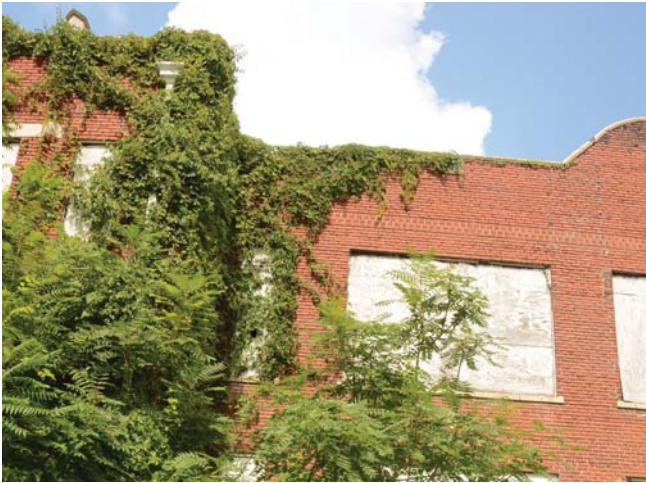
Figure 47. Vegetation growth on exterior walls.

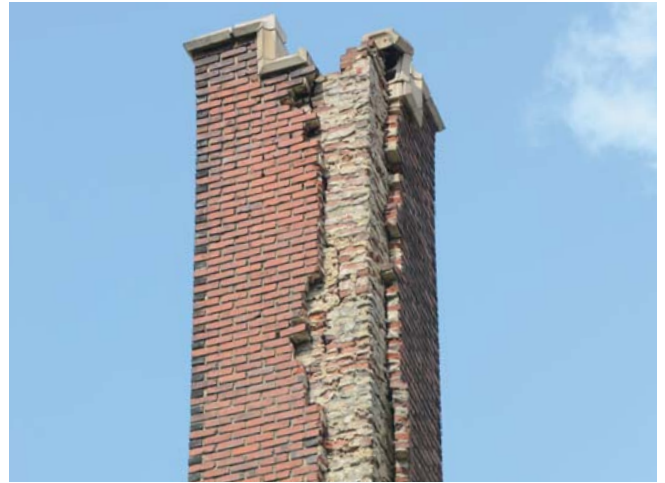
Figure 48. Brick Chimney showing failure of face brick.

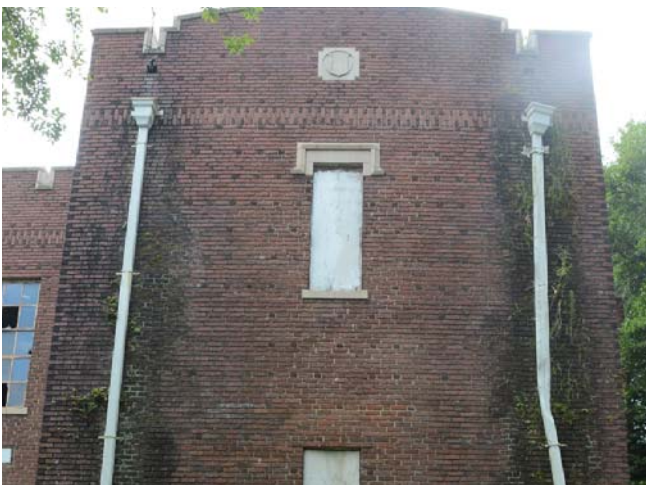
Figure 49. Environmental and biological discoloration near downspouts.

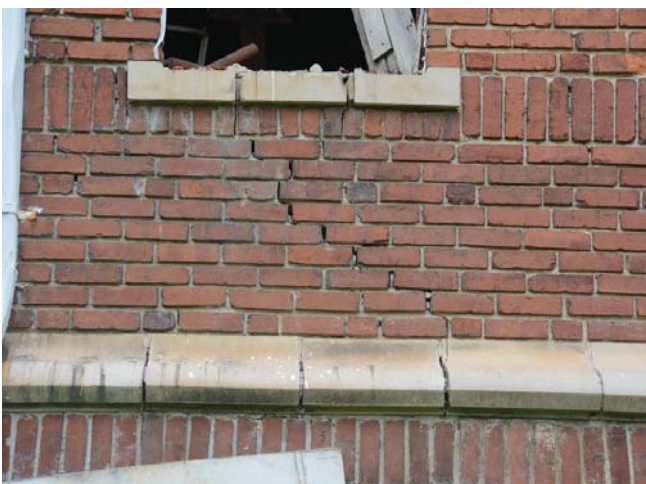
Figure 51. Isolated step cracking on west elevation.

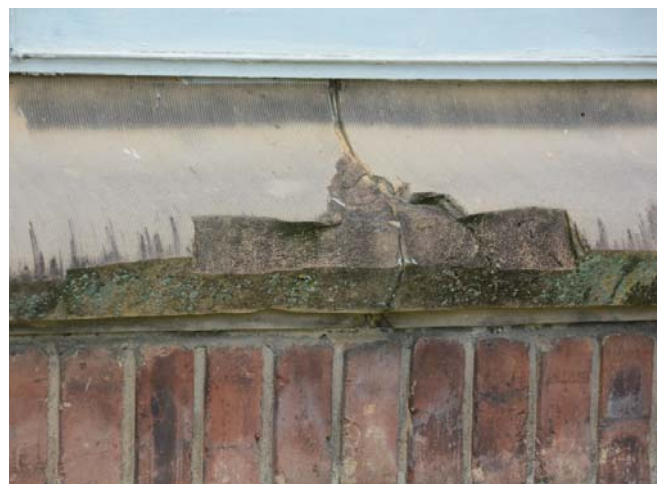
Figure 52. Typical terracotta damage.

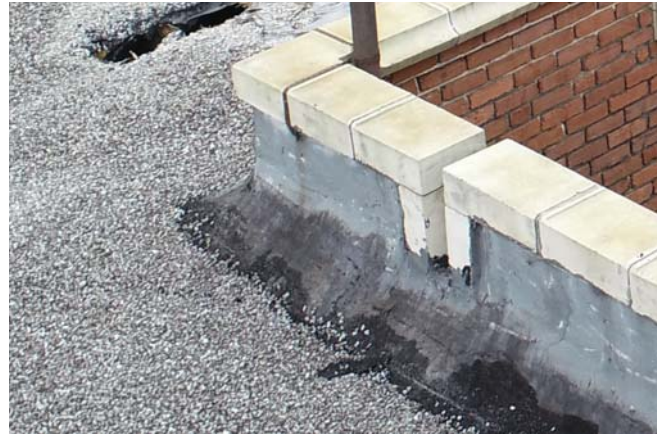
Figure 53. Terracotta parapet with built-up flashing

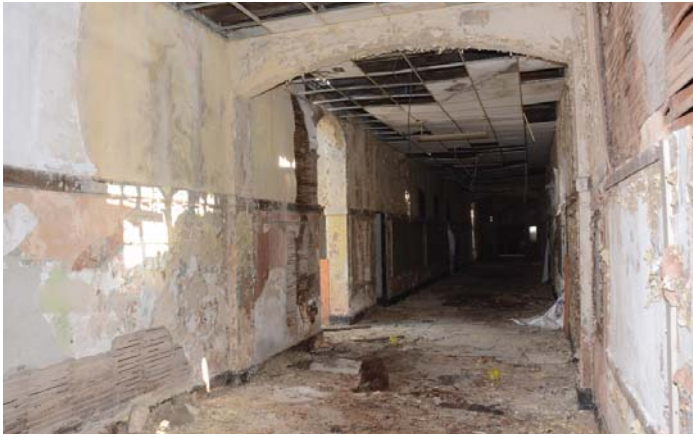
Figure 56. Typical condition of corridor walls.

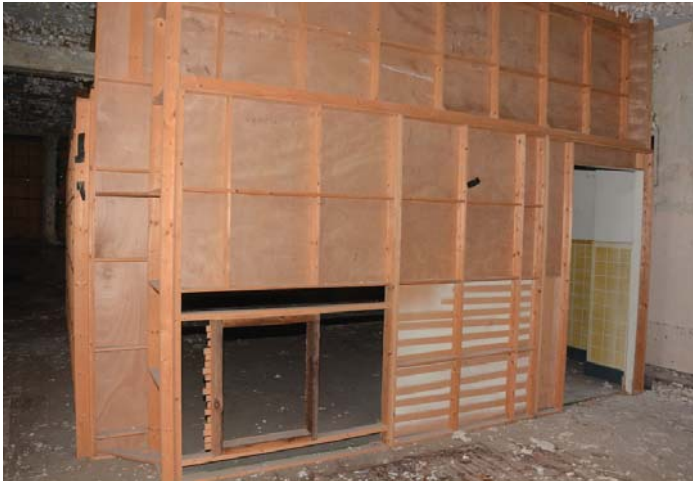
Figure 57. Non-historic walls to be removed.

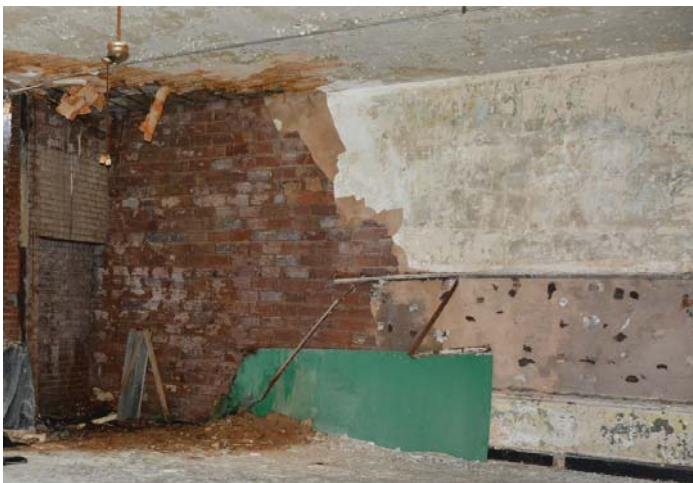
Figure 58. Classroom wall showing failed plaster next to stable plaster. A vertical joint will be cut at the stable plaster.

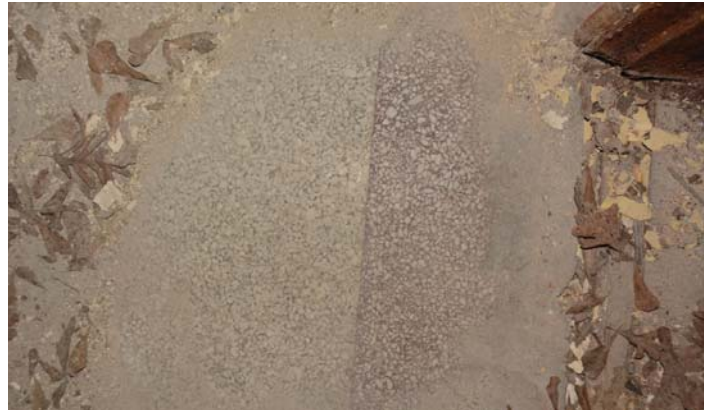
Figure 62. Two-tone terrazzo floors.

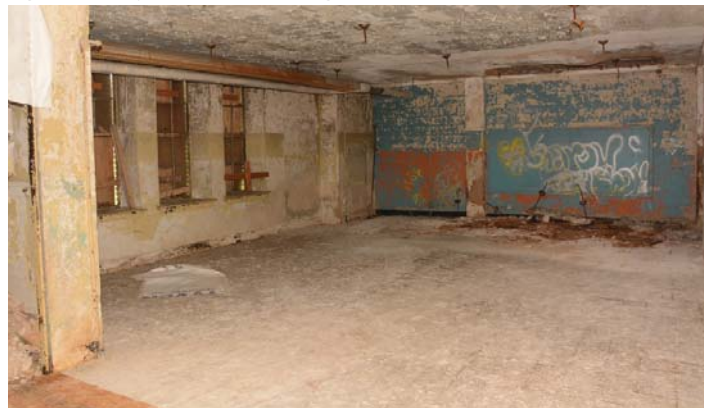
Figure 61. Concrete floors in the wings are generally in stable condition.

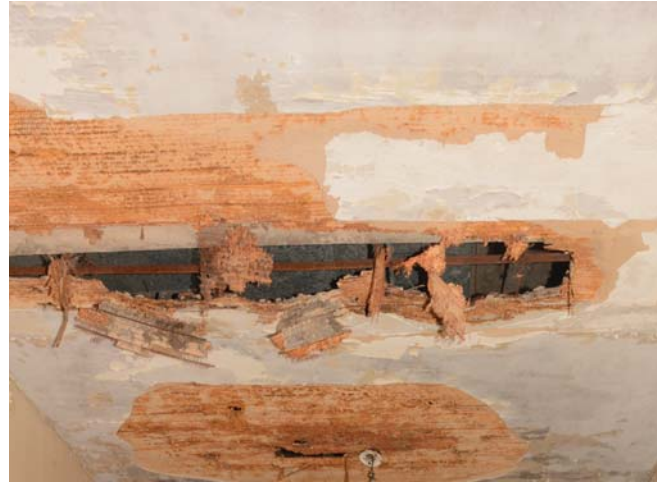
Figure 63. Plaster ceiling on expanded metal lath.

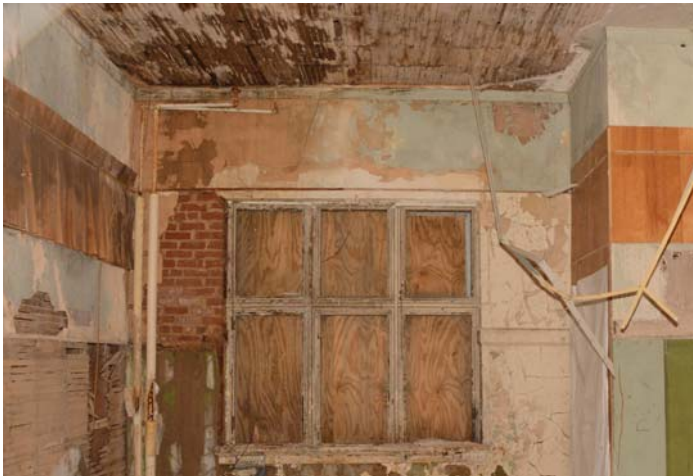
Figure 67. Failed plaster on wood lath ceiling above an intact wood window frame.

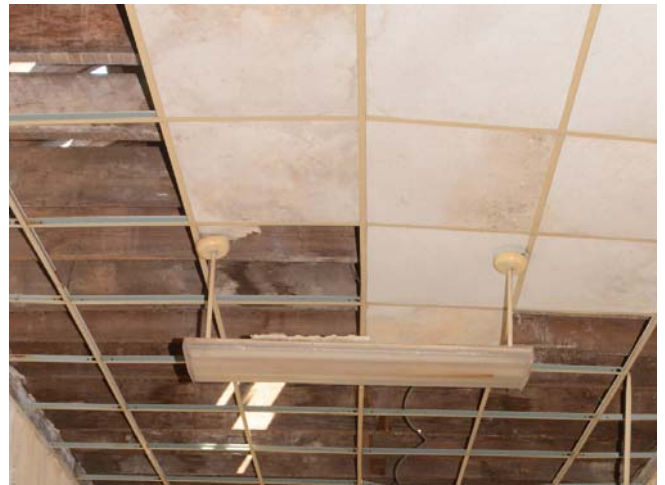
Figure 64. Grid ceiling

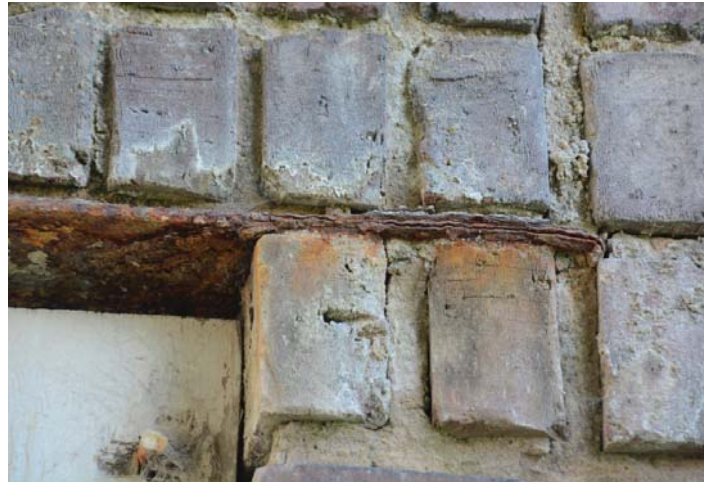
Figure 68. One of the few rusted window lintels that may need to be replaced.

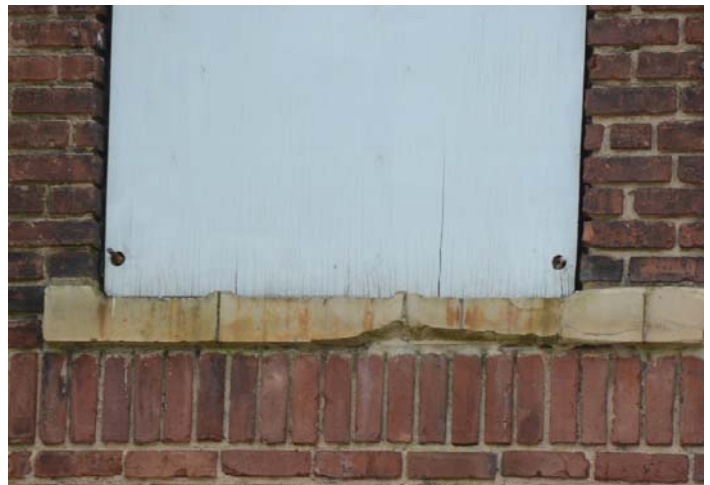
Figure 69. Window Exterior Sill

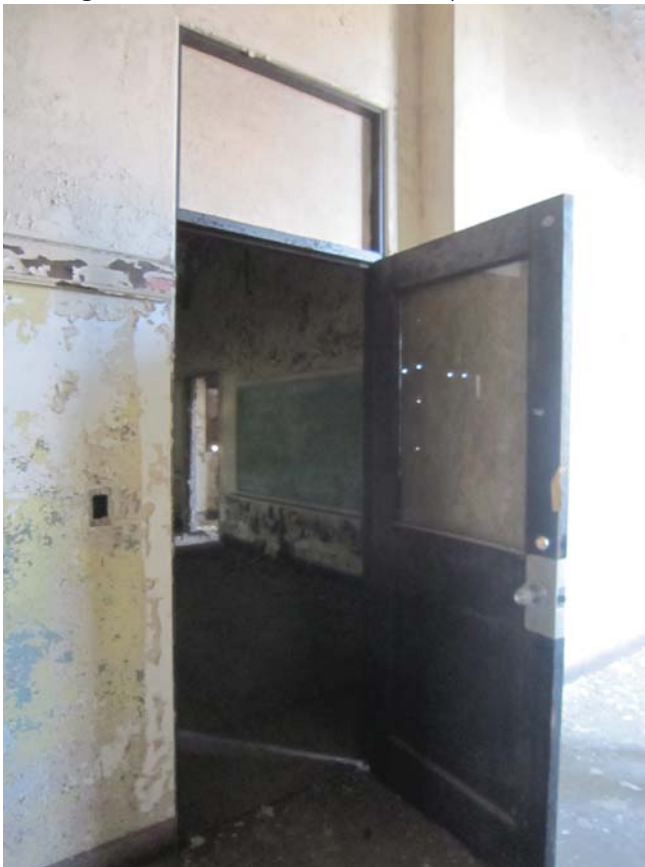
Figure 79. Extant Type B door with boarded up transom lite.

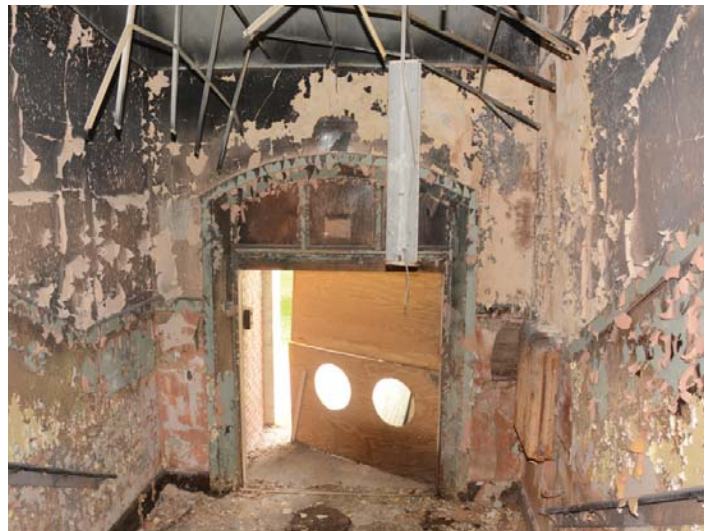
Figure 77. Missing doors as west entrance to the building.

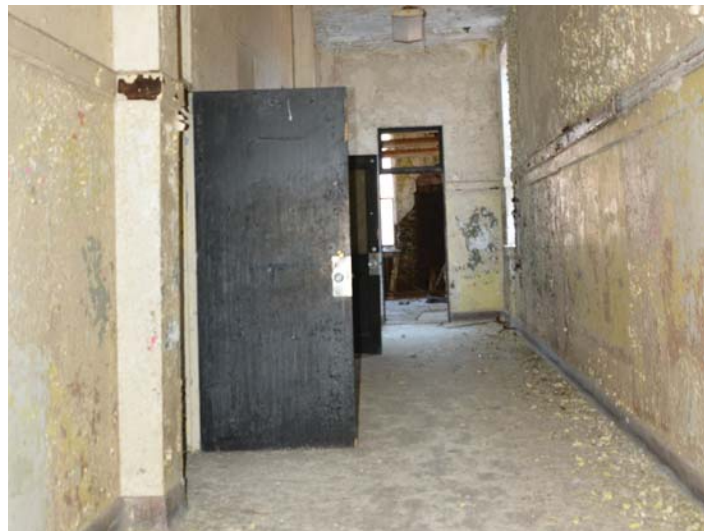
Figure 78. Non-historic interior flush door.

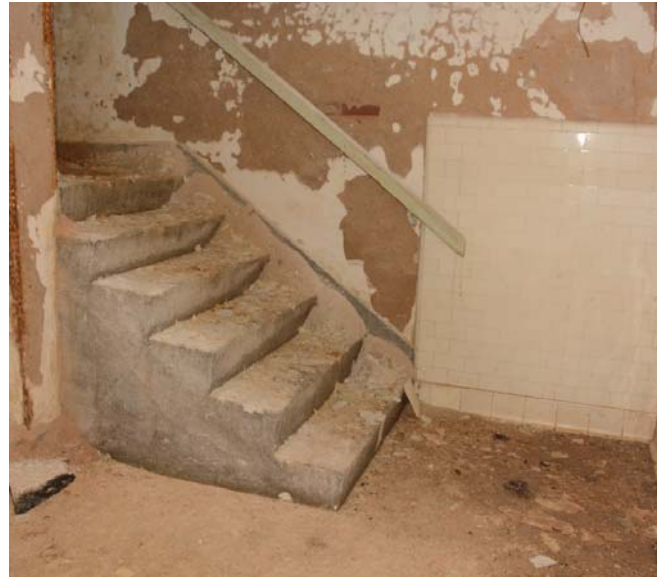
Figure 81. Concrete stairs leading to Auditorium.

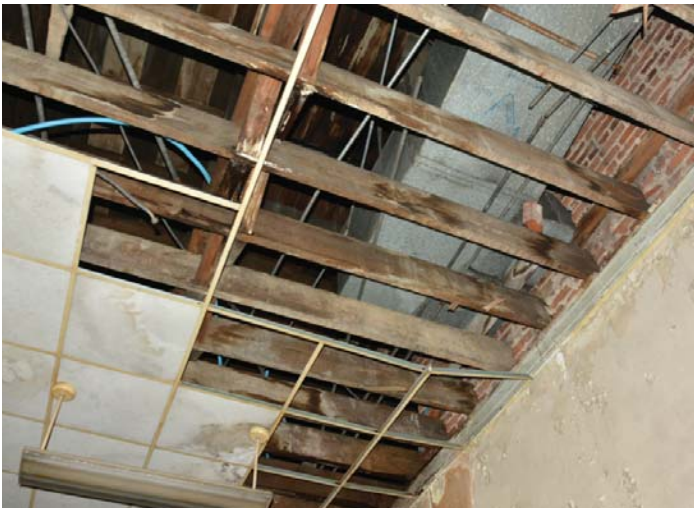
Figure 82. Old Mechanical Ducts in Ceiling at Third Floor
