HAIGHT DAVIS & ASSOCIATES, INC.

May 30, 2018

Re: Structural Evaluation – English Avenue Elementary School, 627 English Avenue,
Atlanta, GA
Project No. ST-18-118

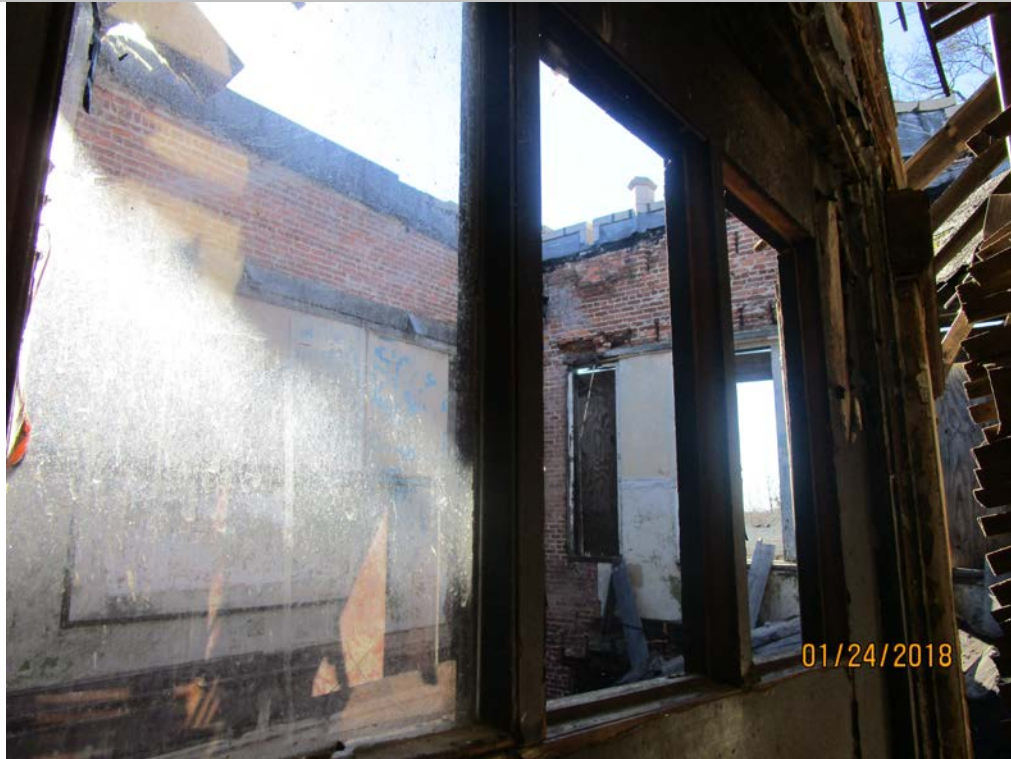
PHOTO 11

During our evaluation, we attempted to access as much of the structure as possible to conduct our visual evaluation. However, some areas of the structure have collapsed floor and roof systems and were unsafe for us to access (*Photos 11-14*). Every attempt was made to evaluate these unsafe areas from adjacent parts of the building. Additionally, other areas remain covered with parge coatings, plaster or wall panels and could not be properly evaluated in their current condition.

Part of the structure has collapsed.

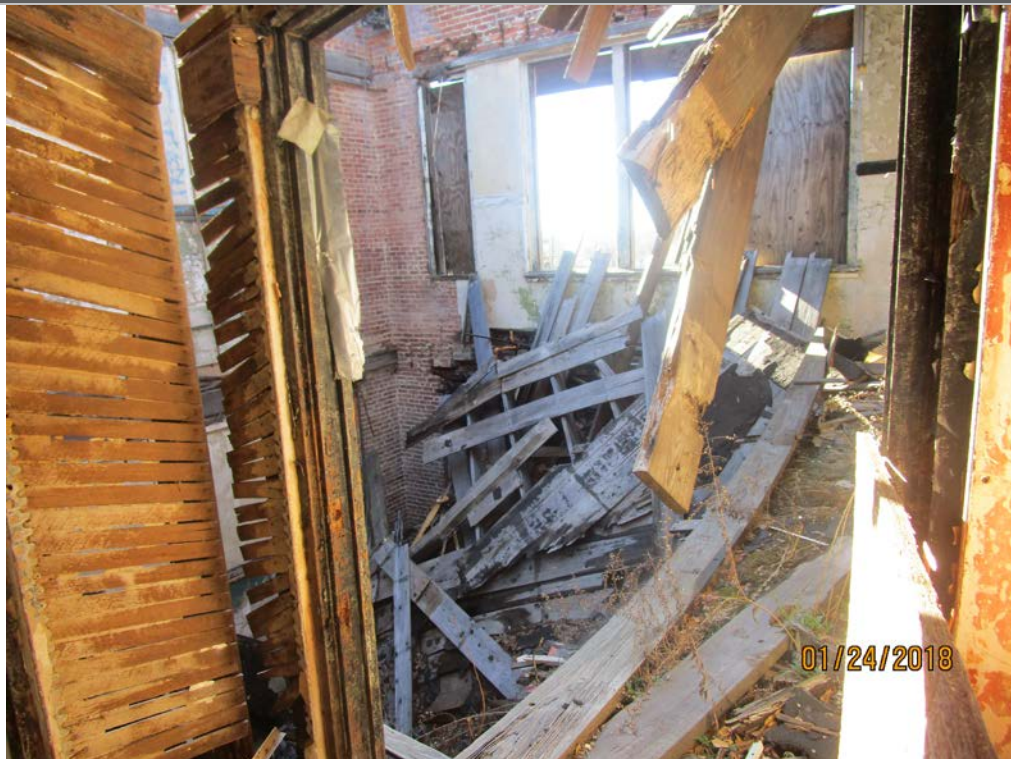
PHOTO 12

Part of the structure has collapsed.

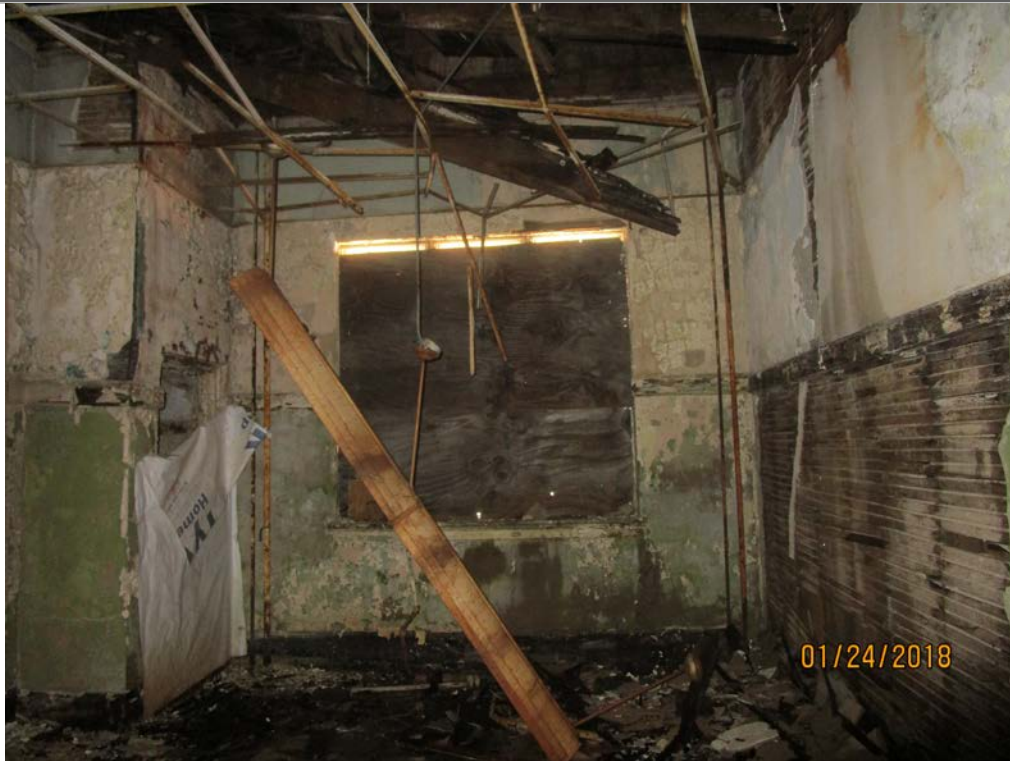
PHOTO 13

Part of the structure has collapsed.

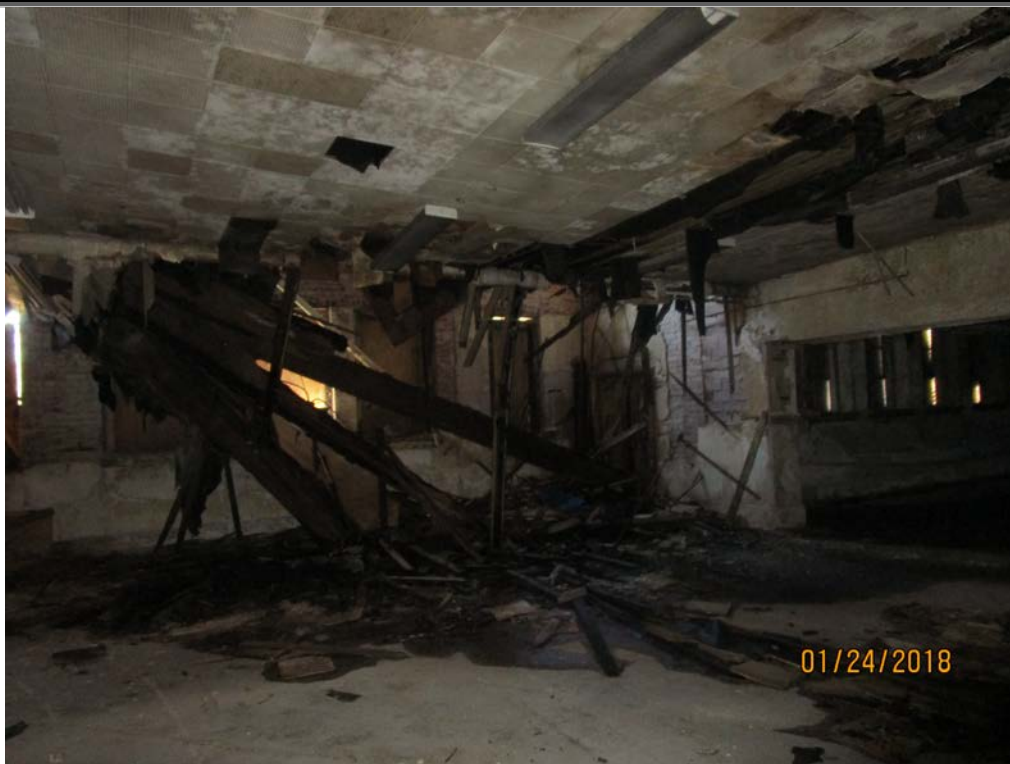
PHOTO 14

Part of the structure has collapsed.

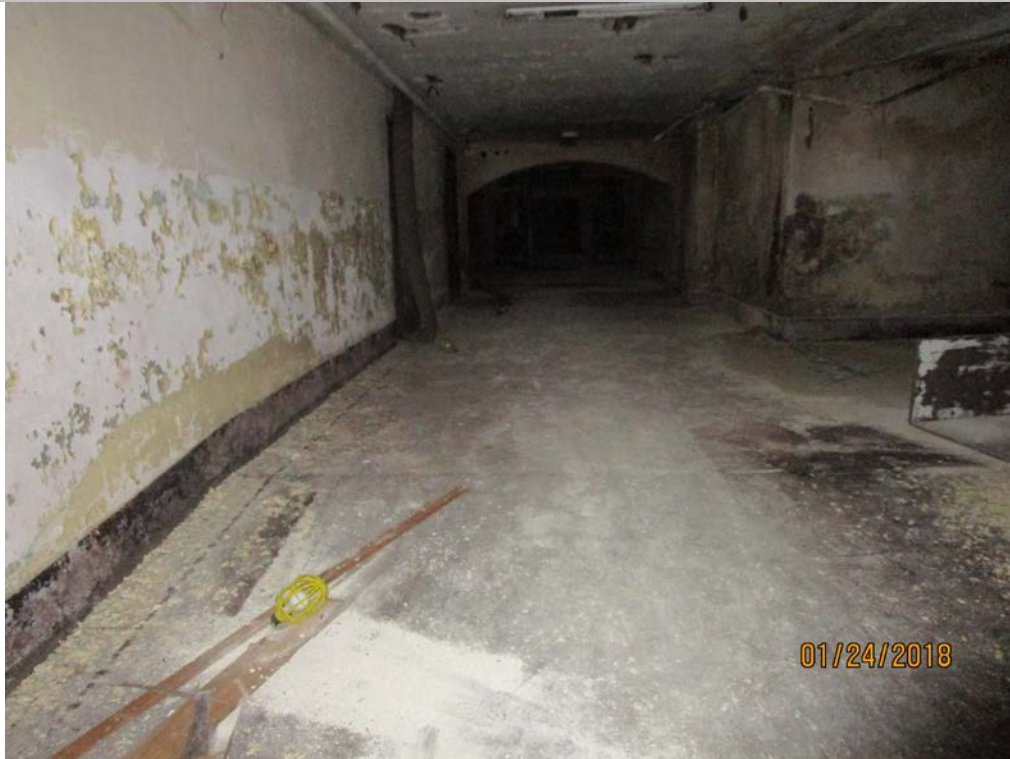
PHOTO 15

1. **Concrete.** The concrete elements of the foundation, basement slab and left and right wing stairs that we were able to evaluate are in good condition (*Photos 15-17*). There are some areas where minor damage was noted such as the surface of the concrete stairs (*Photo 18*). However, it is our opinion that these elements can be successfully repaired during rehabilitation.

Concrete slab at basement level is in good condition.

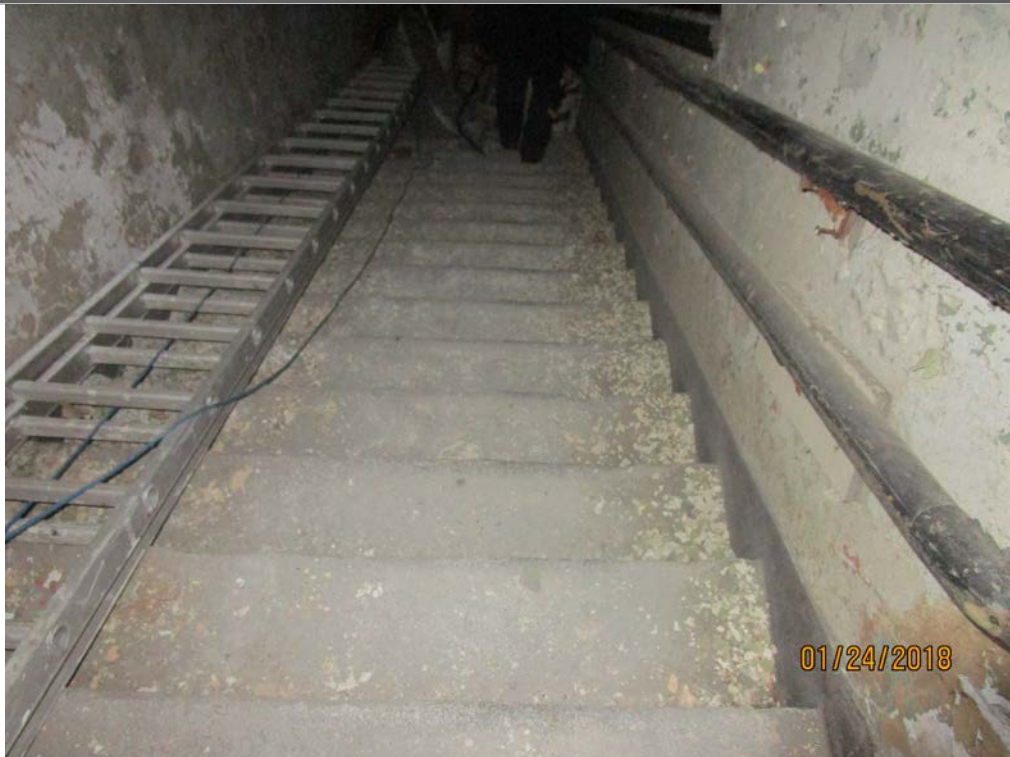
PHOTO 16

Concrete stairs are in good condition.

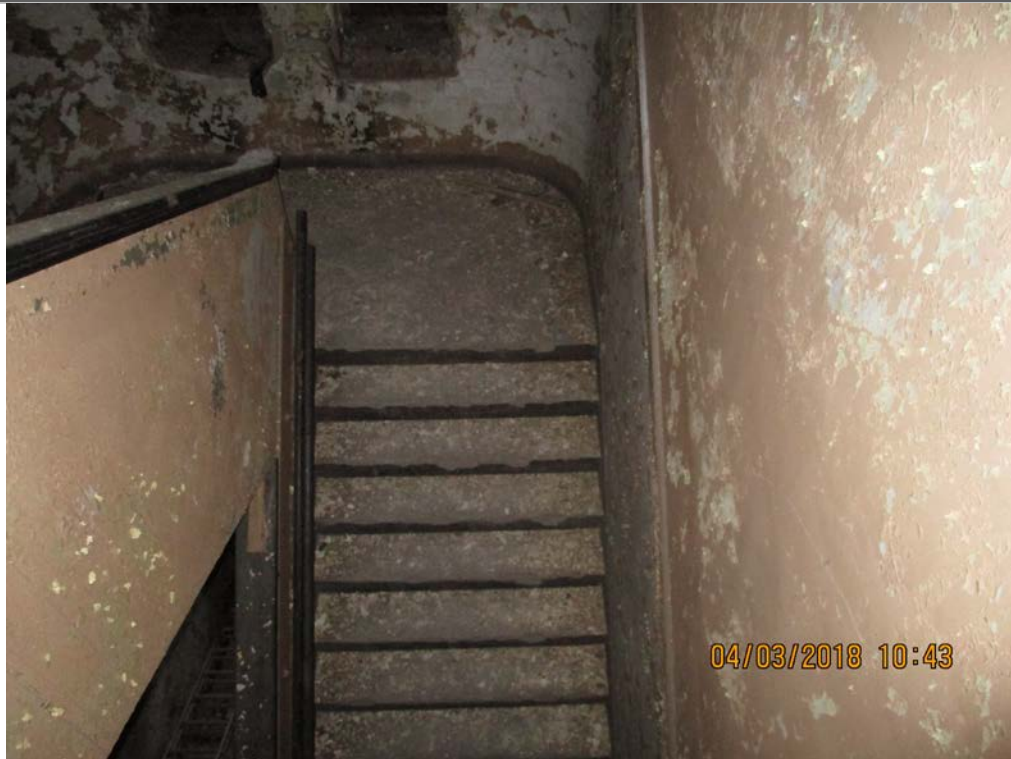
PHOTO 17

Concrete stairs are in good condition.

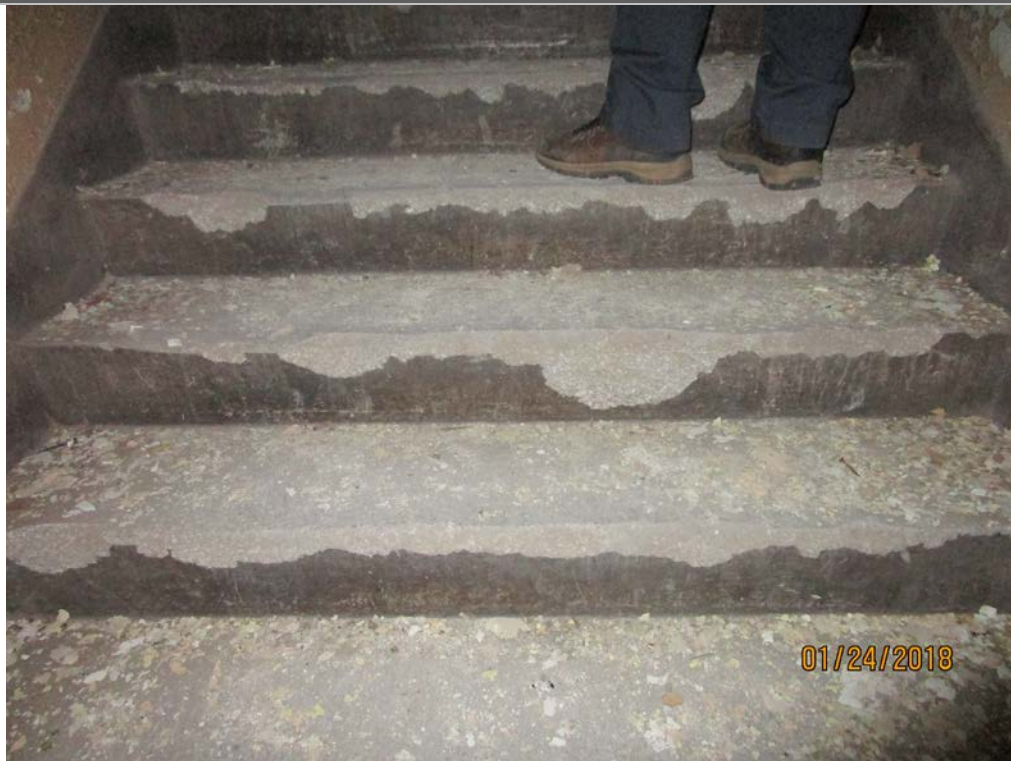
PHOTO 18

Some damage to concrete stairs that can be repaired.

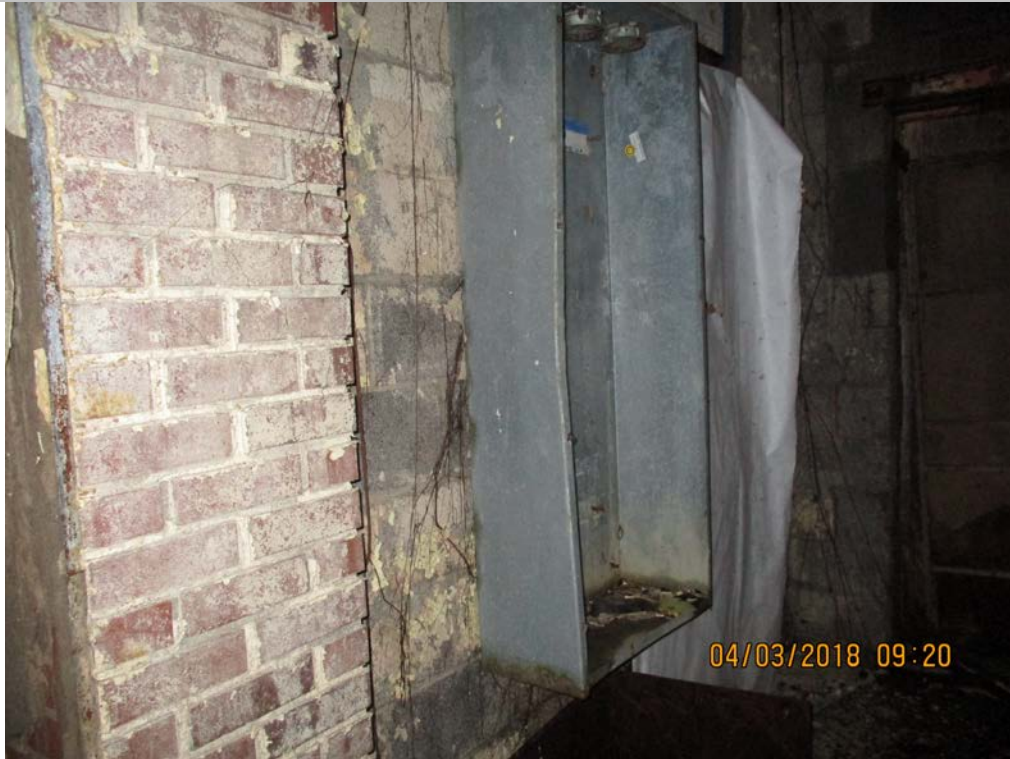
PHOTO 19

2. **CMU Block.** There are a few areas where the foundation consists of CMU block. The CMU block foundation in these areas is in good condition. Of the areas that were accessed consisting of a CMU block foundation, no damage was noted (*Photo 19*). However, based on the condition of the structure, some minor damage may be discovered during rehabilitation. It is our opinion that any damaged areas can be successfully repaired if needed.

CMU block foundation wall in good condition.

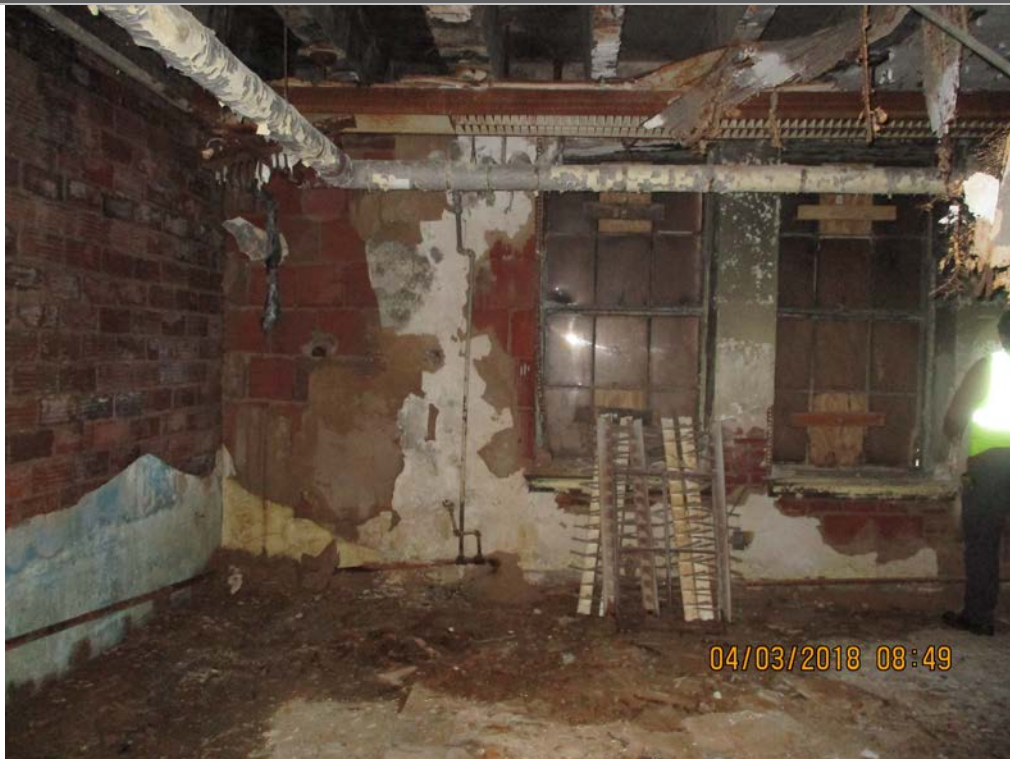
PHOTO 20

3. **Terracotta Brick.** The terracotta brick elements of the foundation that we were able to evaluate are in fair condition. There are some areas that have minor damage (*Photo 20*). However, it is our opinion that these elements can be successfully repaired during rehabilitation.

Terracotta brick foundation wall with minor damage that can be repaired.

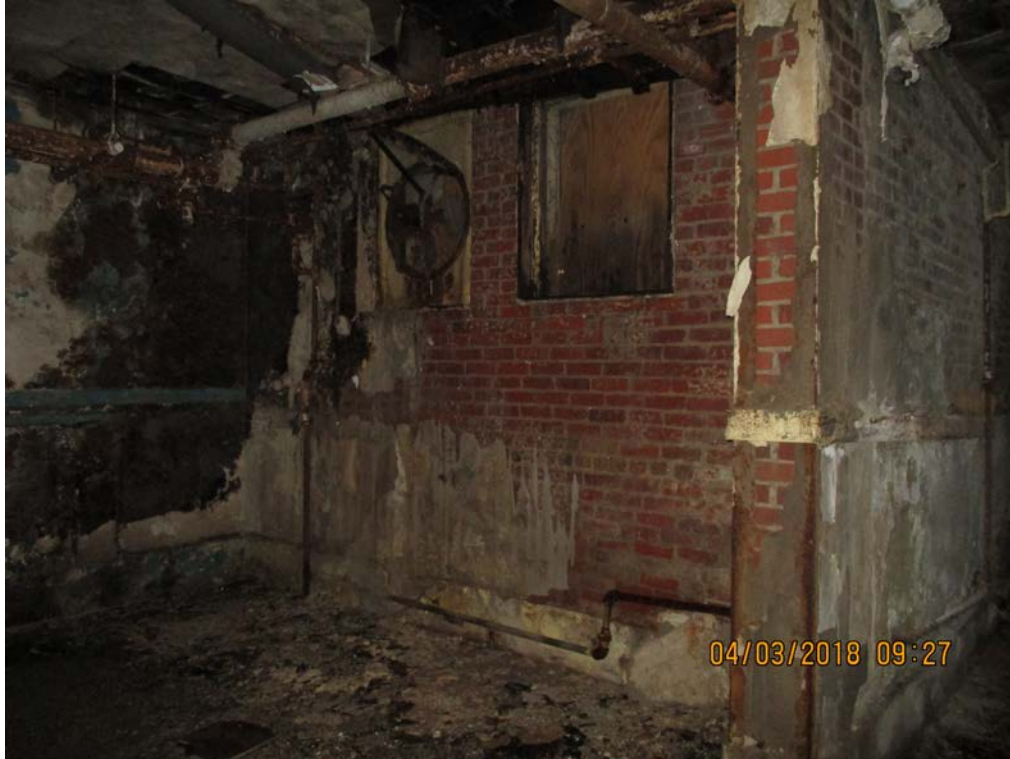
PHOTO 21

4. **Structural Brick.** The structural brick throughout the building consists of multi-wythe bricks. The structural brick elements of the foundation that we were able to evaluate are also in good condition (*Photo 21*). There are some areas that have minor damage. However, it is our opinion that these elements can be successfully repaired during rehabilitation.

Structural brick foundation wall that is in good condition.

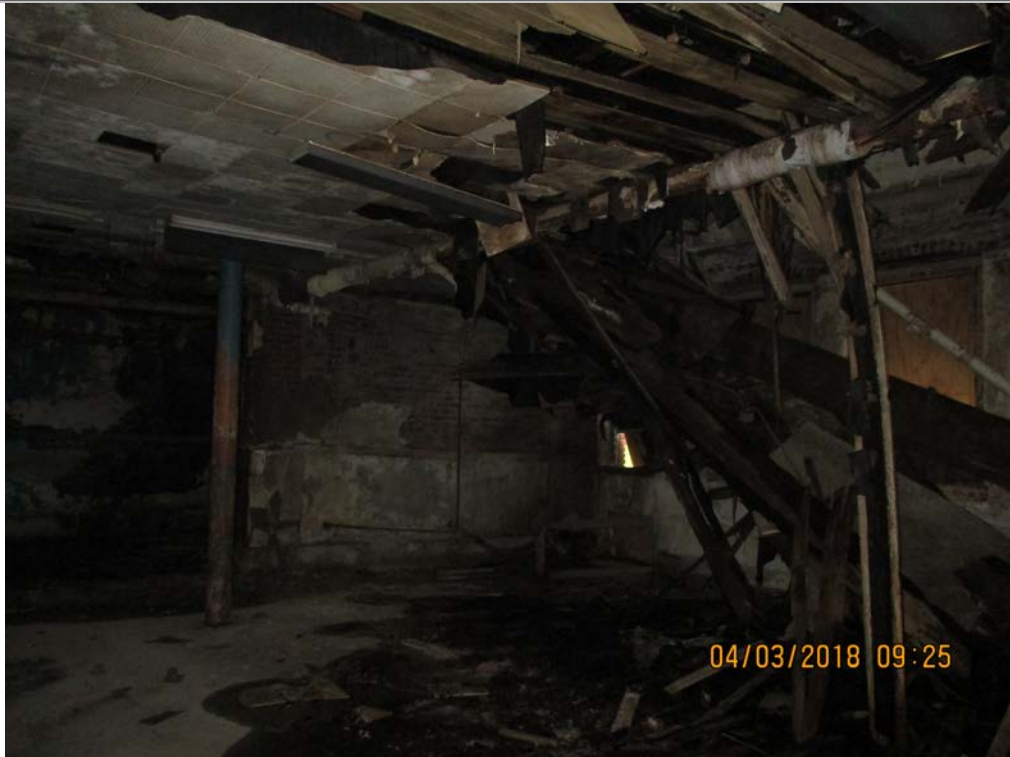
PHOTO 22

1. **Wood Framing.** The floor framing in the original building area consists primarily of wood framing elements. The wood floor systems are in very poor condition. In some areas, the wood framed floors have collapsed due to excessive deterioration from rot and continuous exposure to weather. In other areas, the wood framing components are near failure (*Photos 22-26*). **NOTE: Additional collapse of wood framed floor areas may occur prior to the start of any renovations. Access to the building should be limited because of this unsafe condition.**

Wood floor framing deteriorated and collapsed.

The failed roof system in many areas has resulted in water leaks which have caused the wood rot throughout the building. All wood framed components of the structure will require removal and replacement.

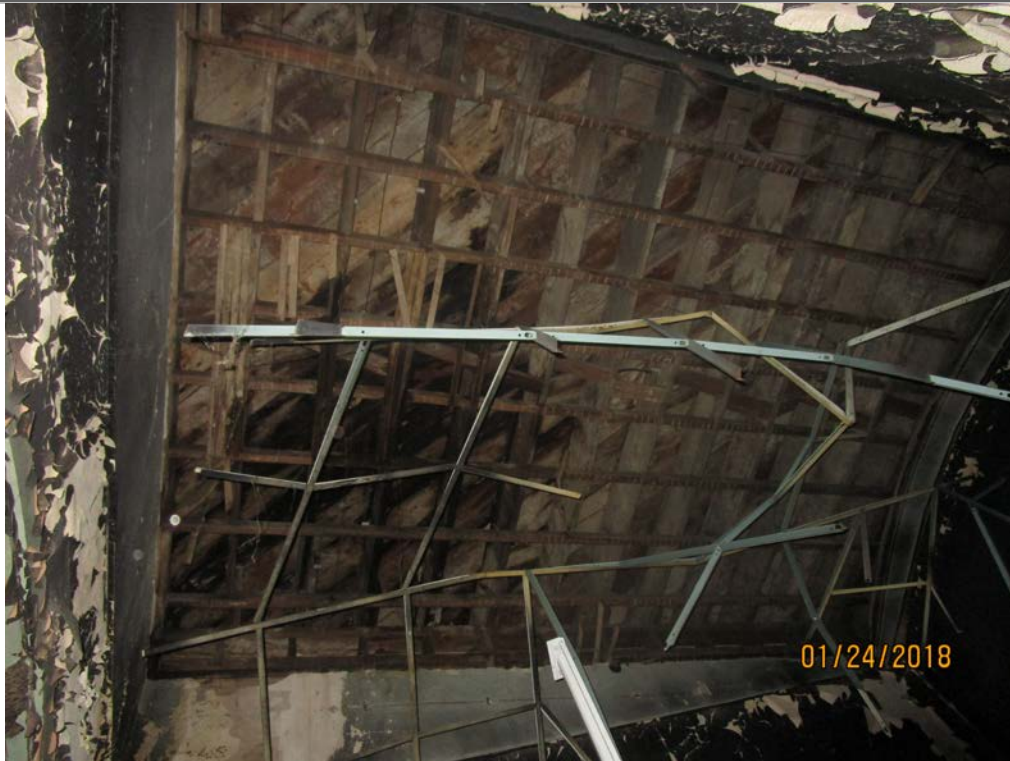
PHOTO 23

Wood floor framing deteriorated.

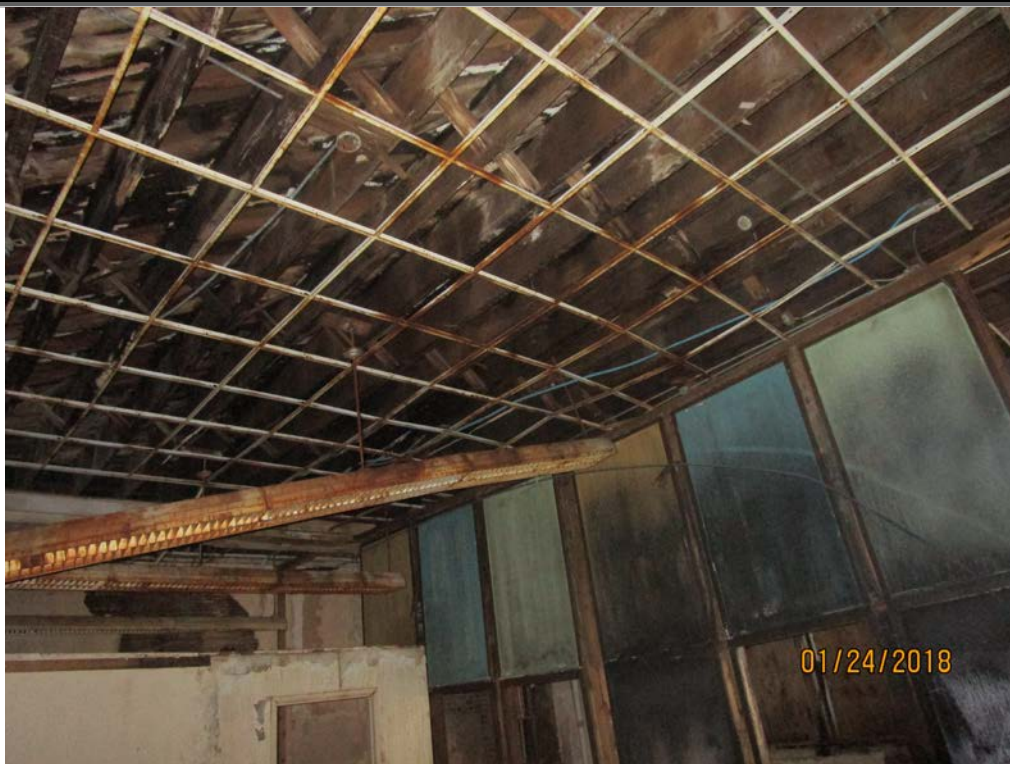
PHOTO 24

Wood floor framing deteriorated.

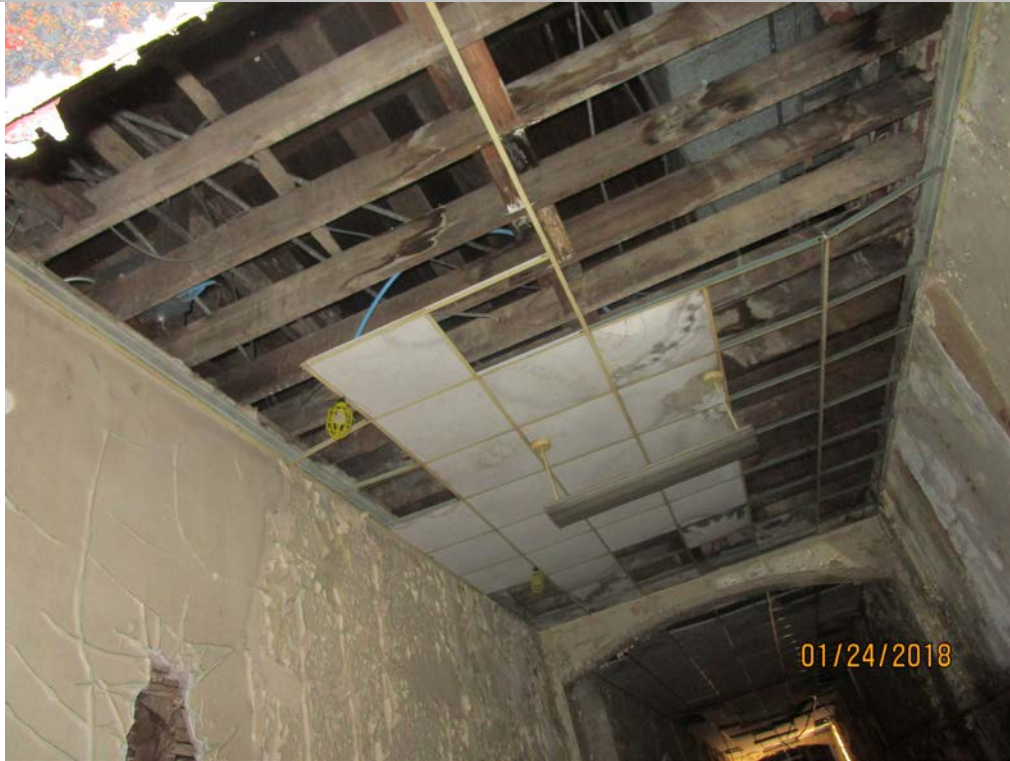
PHOTO 25

Wood floor framing deteriorated.

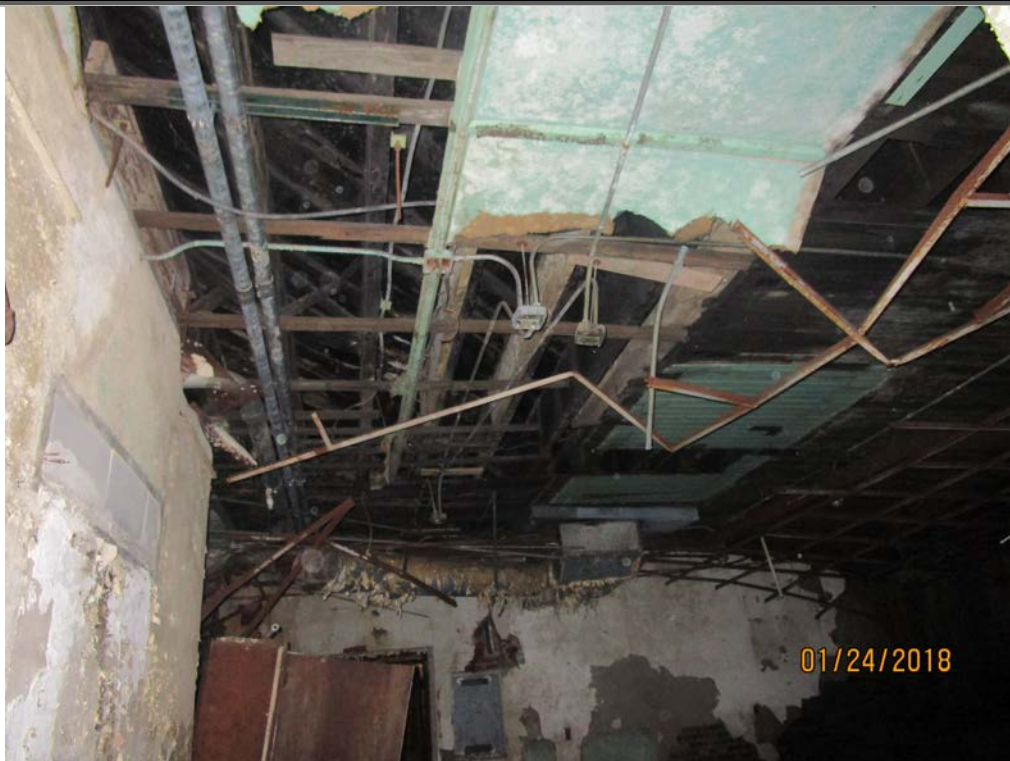
PHOTO 26

Wood floor framing deteriorated.

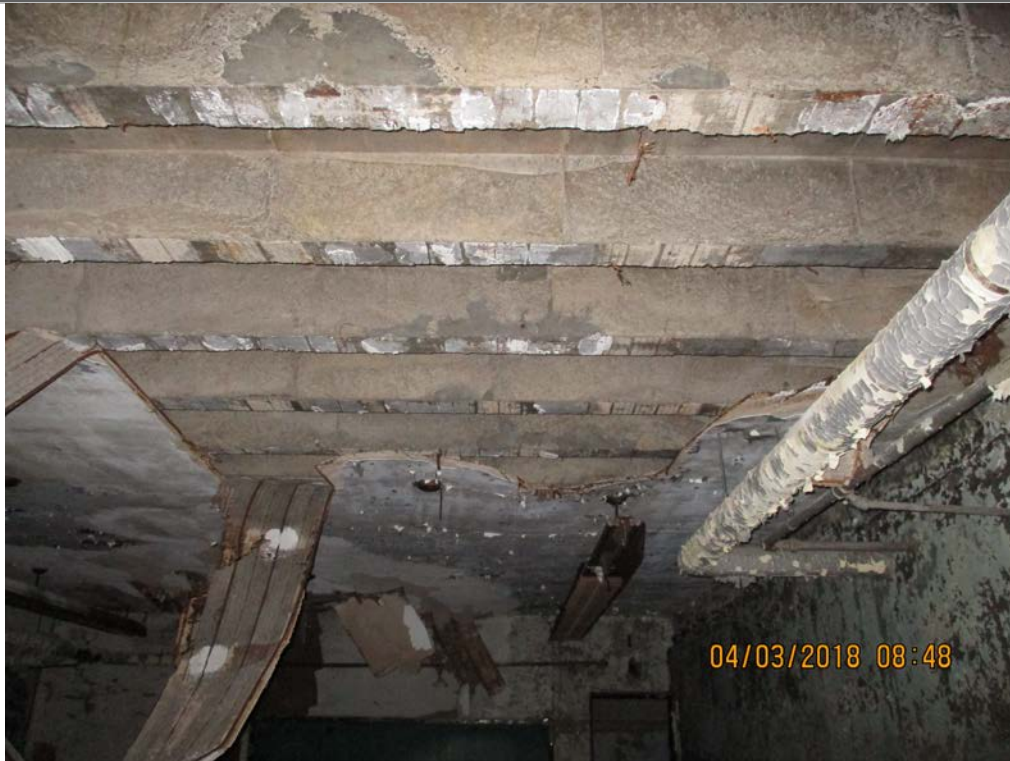
PHOTO 27

2. **Concrete.** The floor systems of the left and right wing additions are constructed of concrete lathed with plaster on the underside and topped with vinyl flooring tiles (*Photos 27-29*). The concrete floor systems are in good condition and can be rehabilitated. Once all materials have been removed, some minor damage may be discovered. However, it is our opinion that any minor damage can be successfully repaired if needed.

Concrete floors covered with plaster underneath.

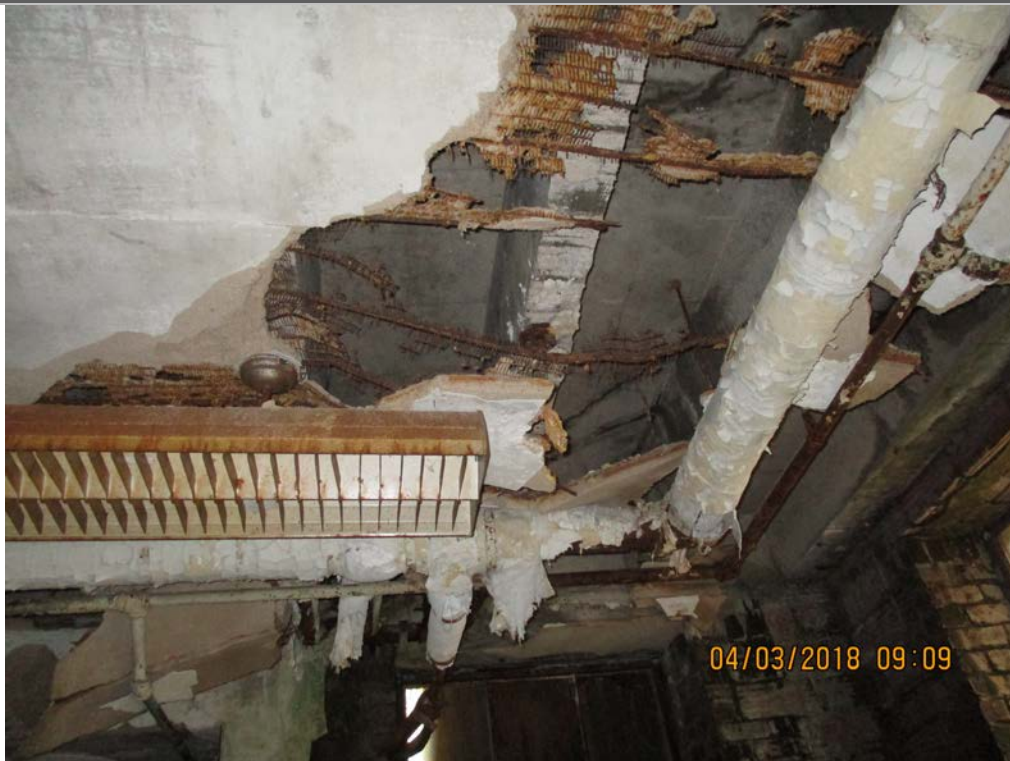
PHOTO 28

Concrete floors with plaster underneath.

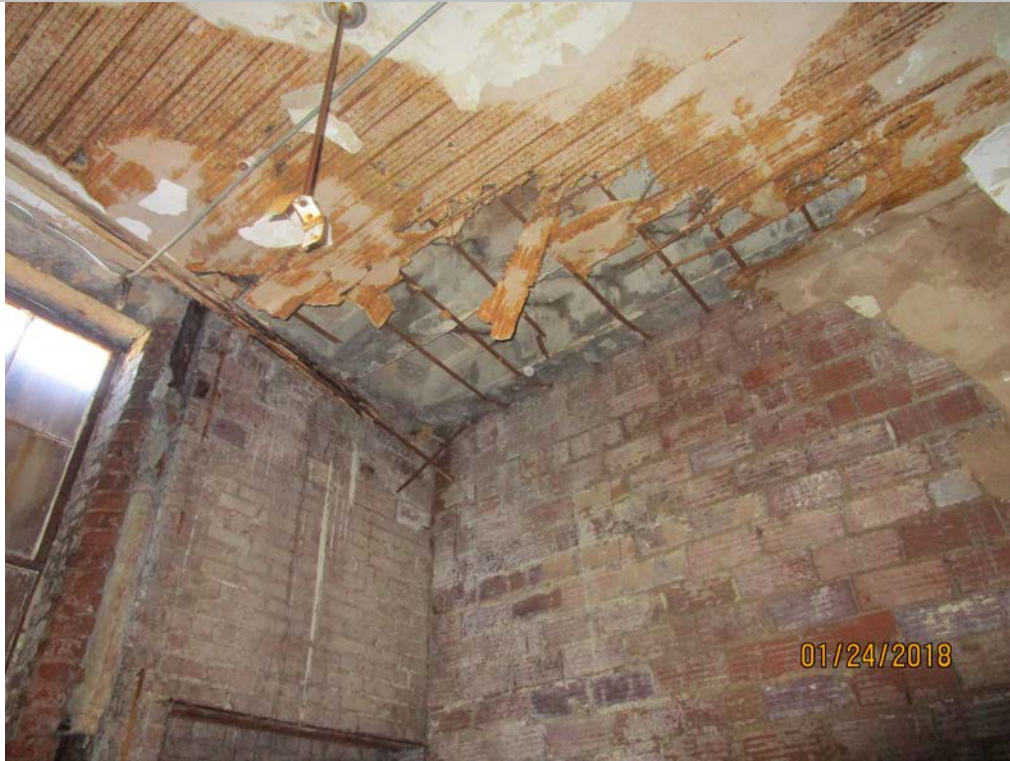
PHOTO 29

Concrete floors with plaster underneath.

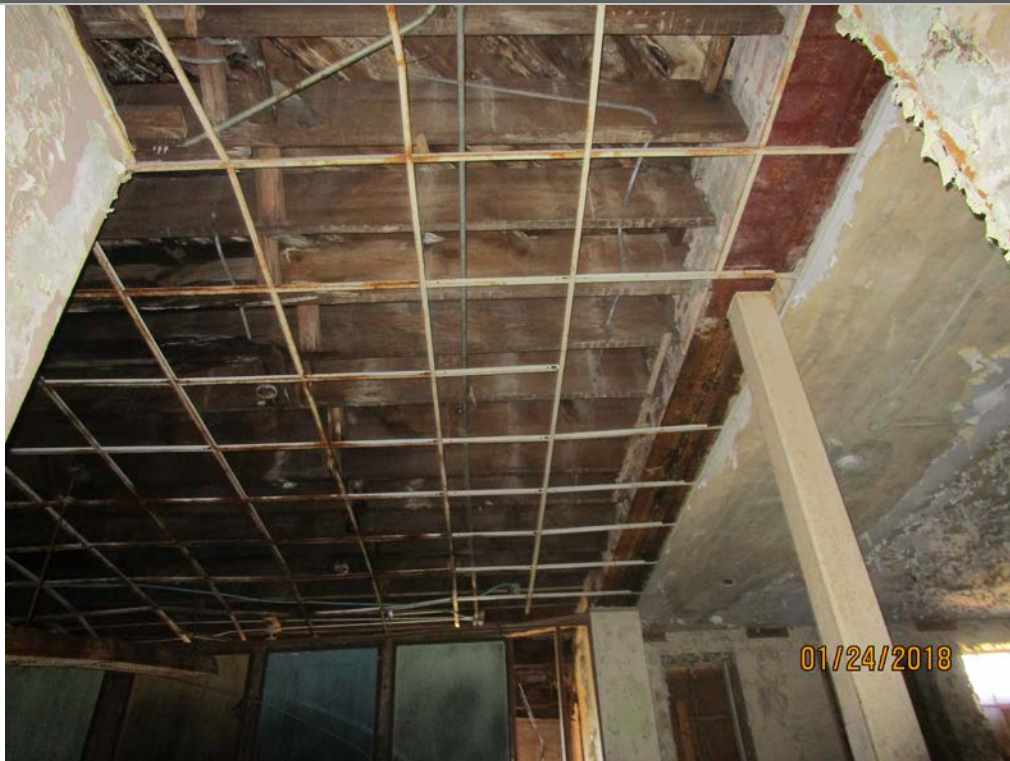
PHOTO 30

3. **Steel Beams.** In some areas, steel beams are present. The beams are in place to provide support for large openings between the original building construction and the newer additions (*Photos 30 and 31*). The beam sections that were visible during our evaluation have been filled with brick between the top and bottom flanges. Therefore, the structural beams could not be properly evaluated.

In areas where sections of the beams are visible, the beams have experienced an excessive amount of surface rusting. A thorough evaluation of the steel beams will be required once the additional materials have been removed and the beams have been cleaned of debris and rust.

Steel support beam.

If the steel beams do not require removal and replacement, reinforcement of the beams will be necessary to meet the current IBC requirements. This work can be accomplished leaving the beams in place and adding additional steel.

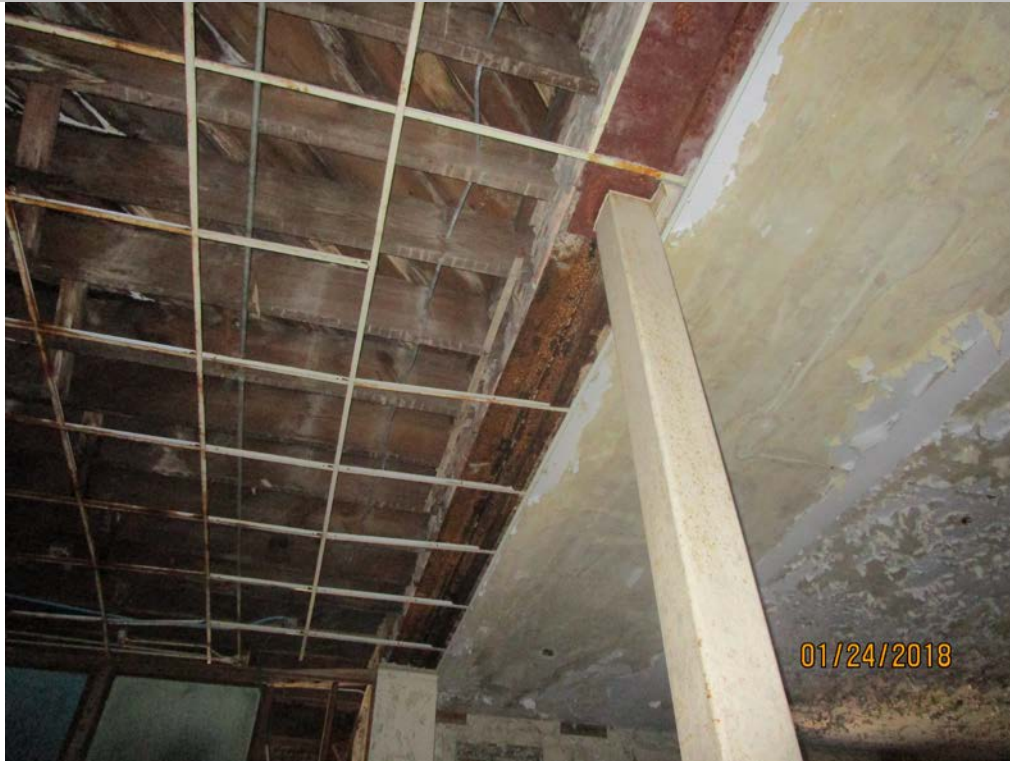
PHOTO 31

Steel support beam.

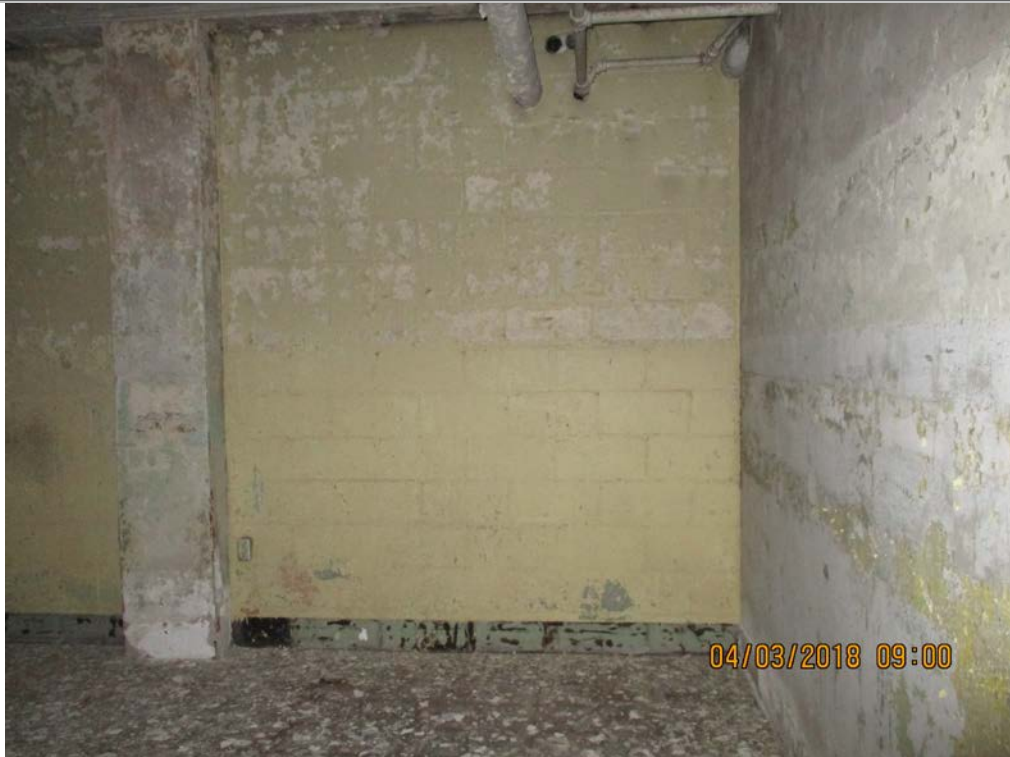
PHOTO 32

4. **CMU Block.** Some of the walls, both interior and exterior, of the newer sections of the building, consist of CMU block. The majority of the CMU block has been used as wall construction for the bathroom and shower areas. Some classroom walls of the newer sections have also been constructed of CMU block (*Photo 32*).

Interior CMU block wall.

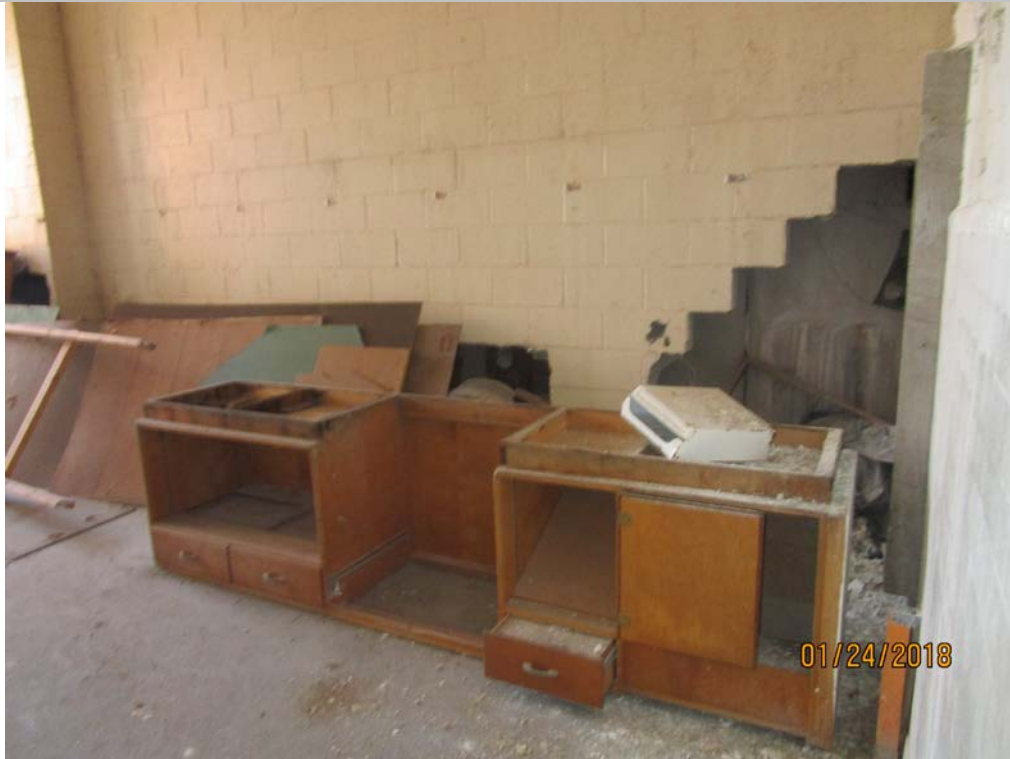
PHOTO 33

A large percentage of the CMU block is in good condition. However, there are some areas, primarily the bathroom and shower, where sections of the CMU block walls have been damaged. The damage is primarily due to vandalism and removal of pipes from within the walls (*Photo 33*).

Interior CMU block wall damaged.

Although some damaged areas exist, the CMU block can be repaired.
