HAIGHT DAVIS & ASSOCIATES, INC.

May 30, 2018

Re: Structural Evaluation – English Avenue Elementary School, 627 English Avenue,
Atlanta, GA
Project No. ST-18-118

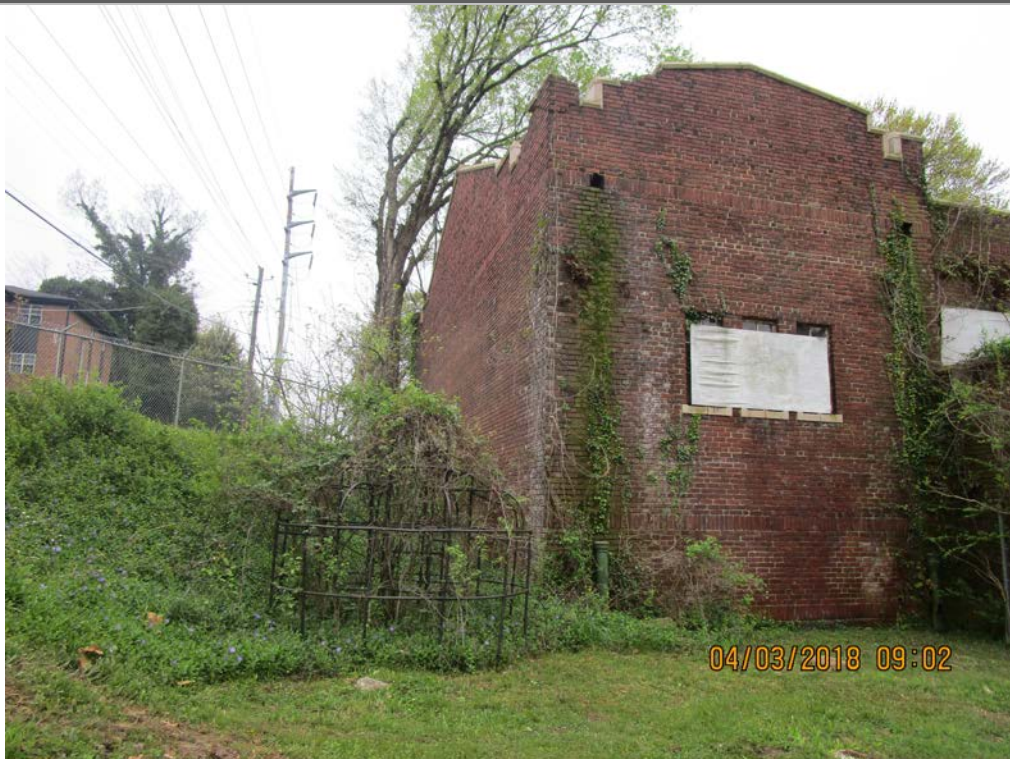
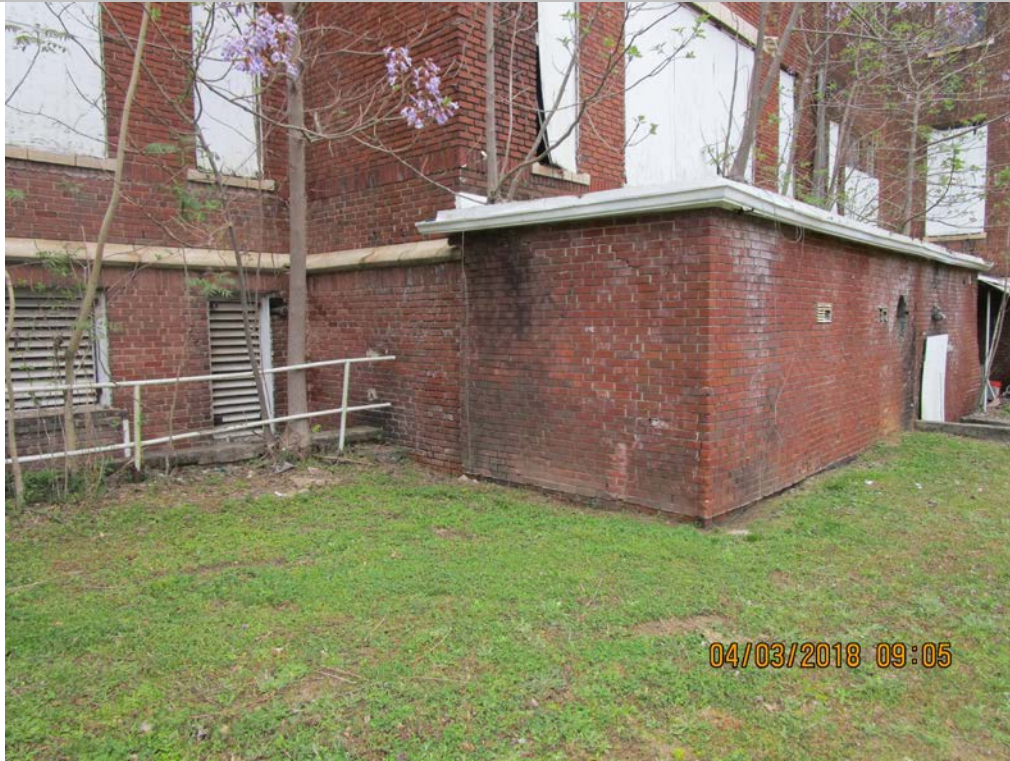
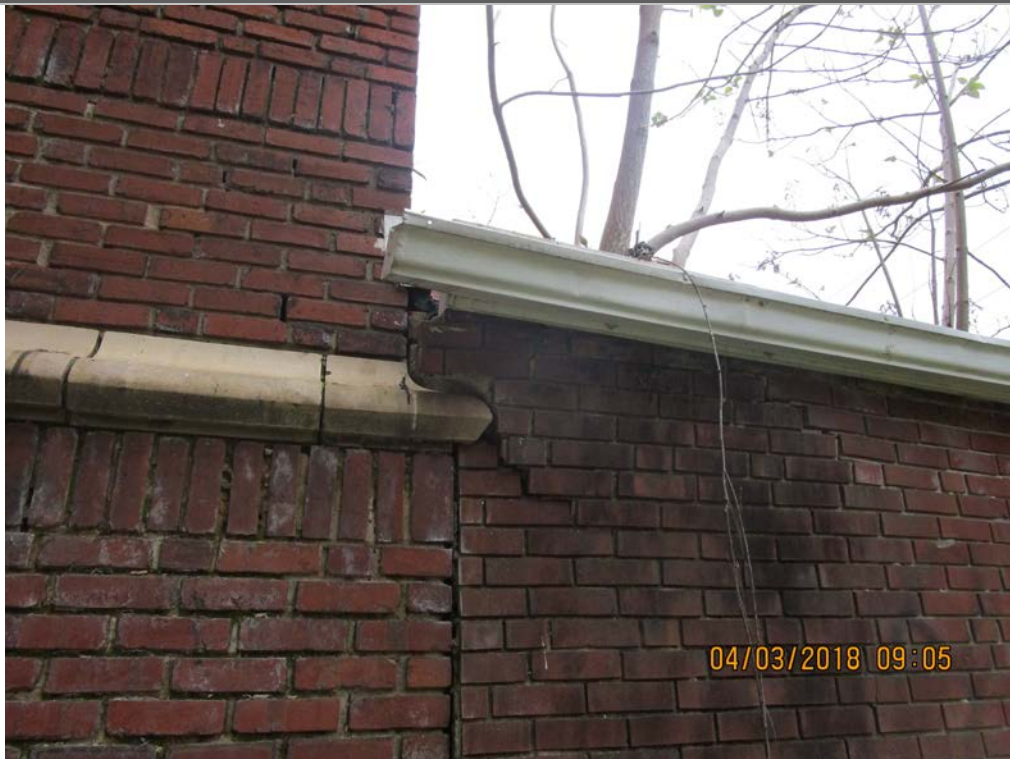
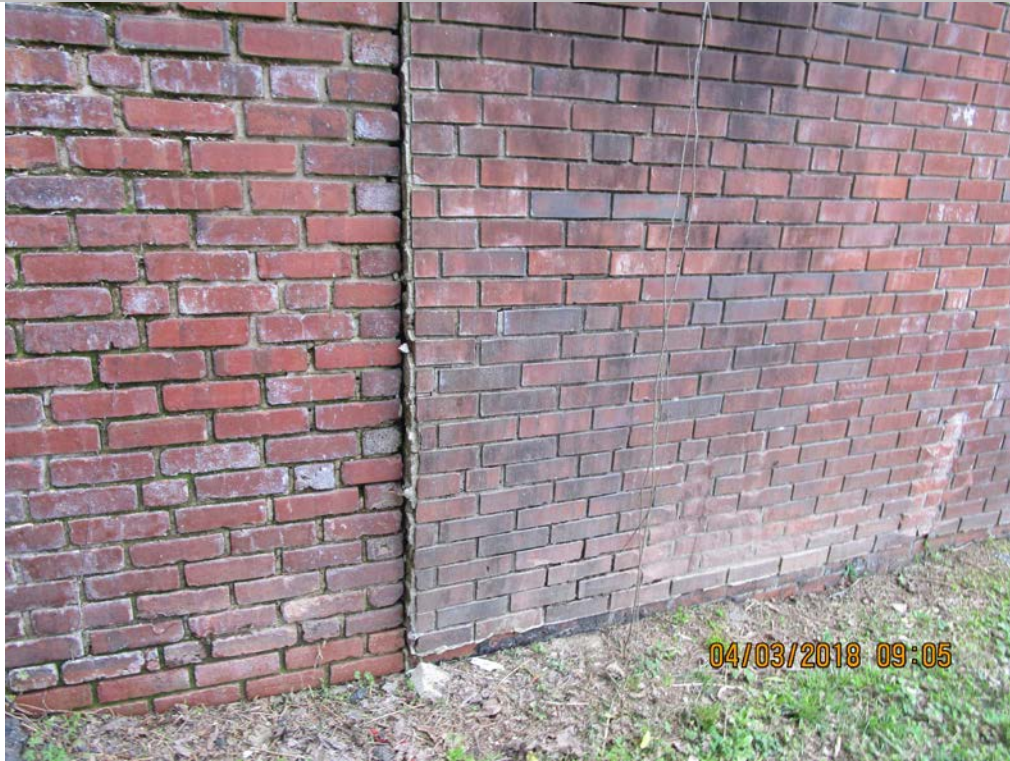
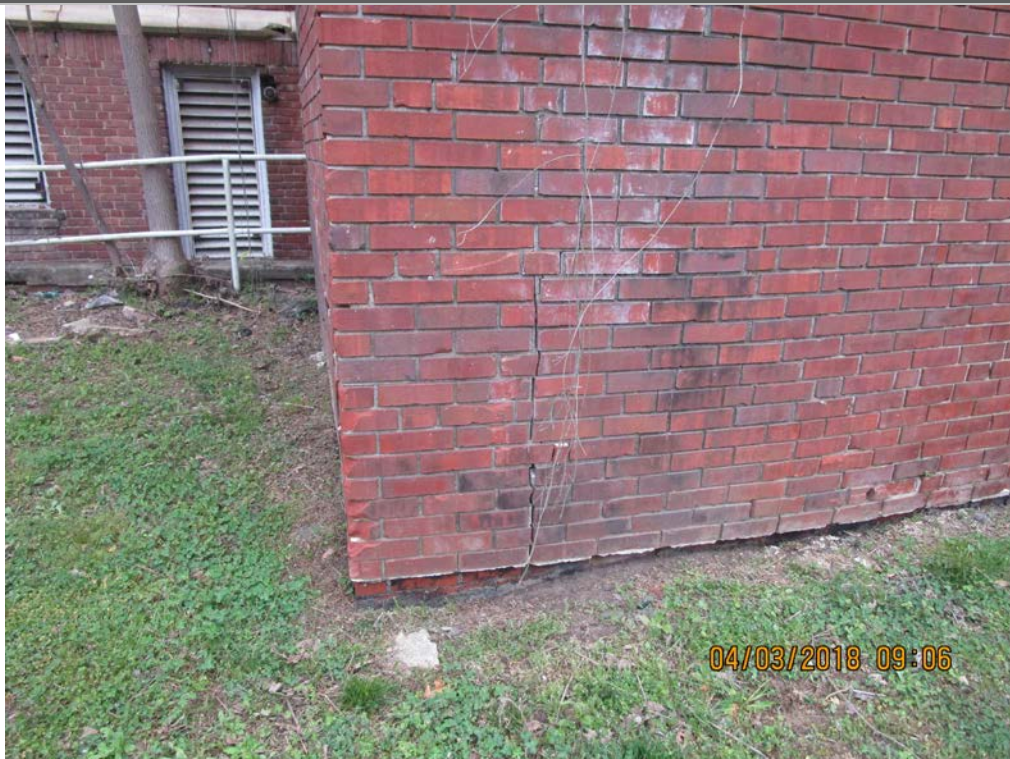
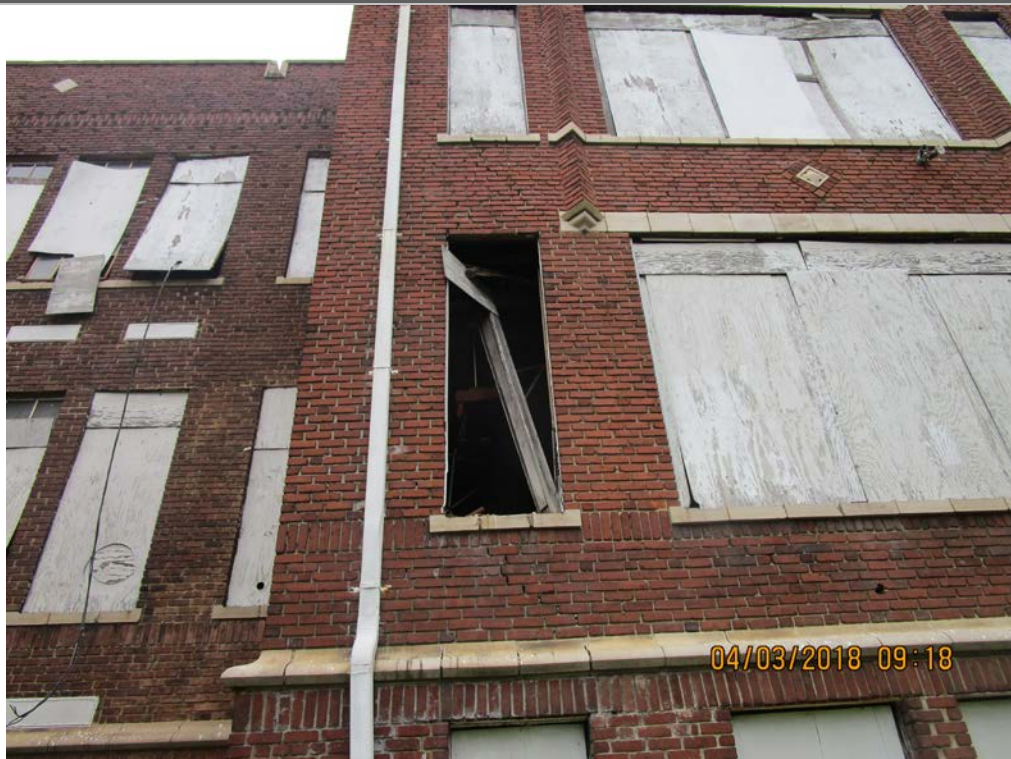
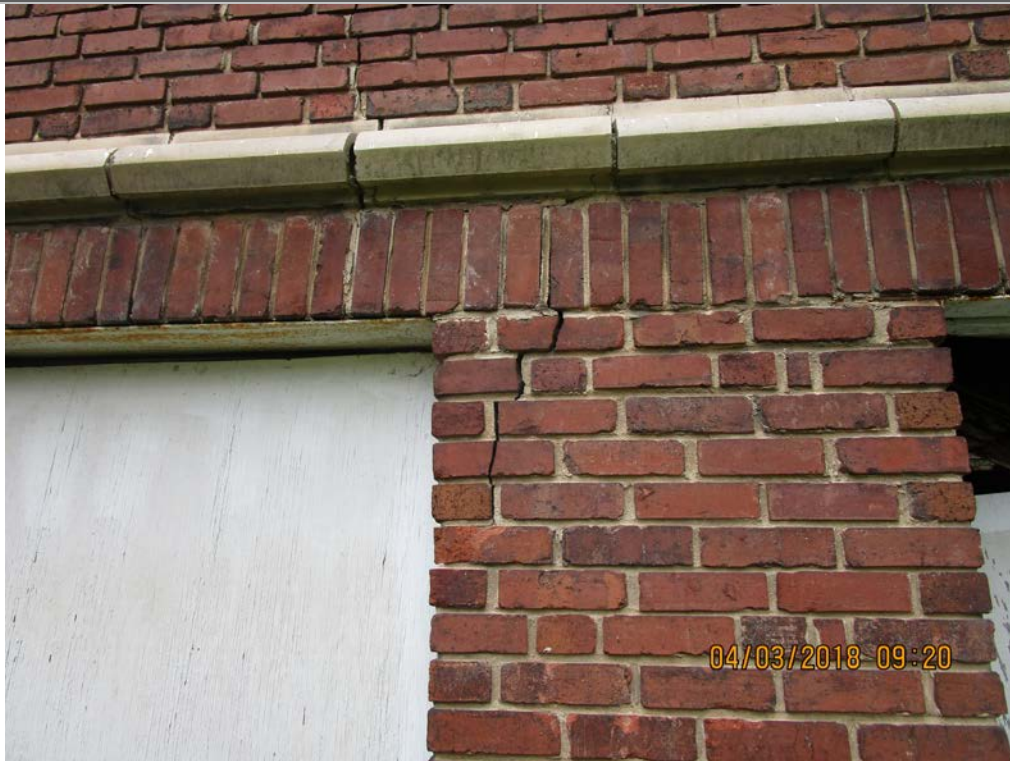
There are, however, some areas where these elements are in distress. We noted distress in areas where the bricks around door and window openings have collapsed. **The brick around the tops of the chimneys has also fallen away, particularly the tall chimney at the center rear of the building. Extreme caution should be exercised in this area.** Bricks are also falling off around the perimeter of the roof in some areas along with some of the parapet stone caps. **The bricks of the rear shed have experienced severe distress and will likely fall away from the structure. Extreme caution should be exercised in this area as well.** There are also some areas where stair-step cracks are present near grade level (*Photos 34-43*).

Exterior brick distress - cracking.

Although the building envelope has some areas of distress, overall, the envelope of the structure is in good condition. The areas of distress can be successfully repaired during renovations.

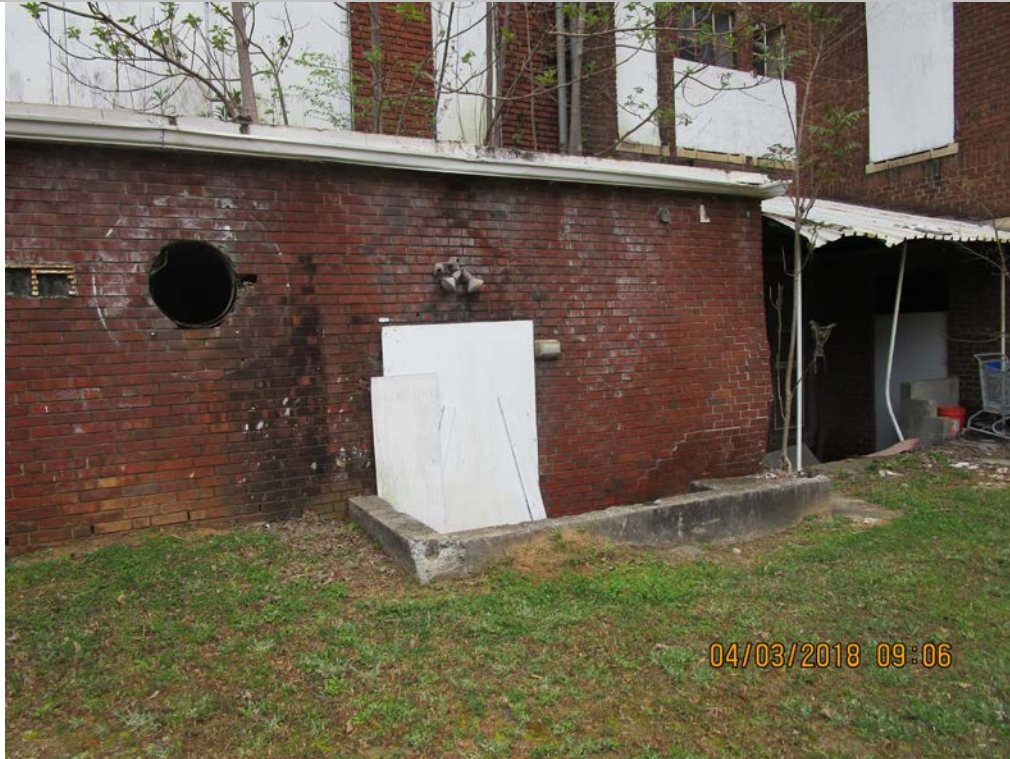
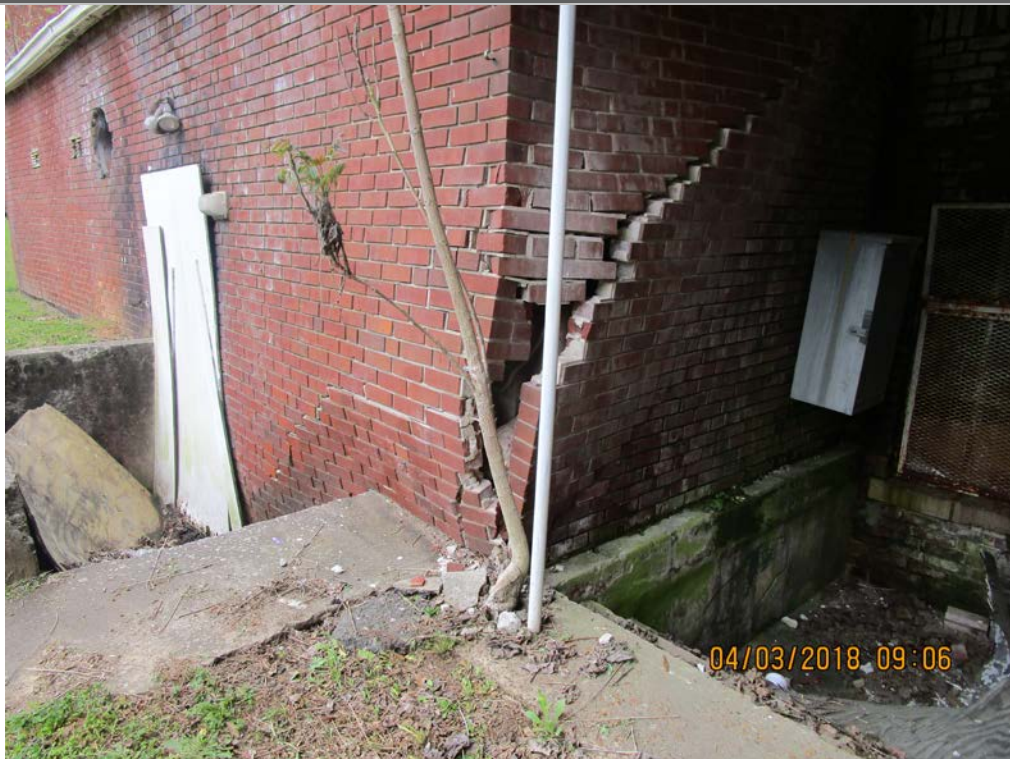
Exterior brick distress – cracking and collapse at attached storage.

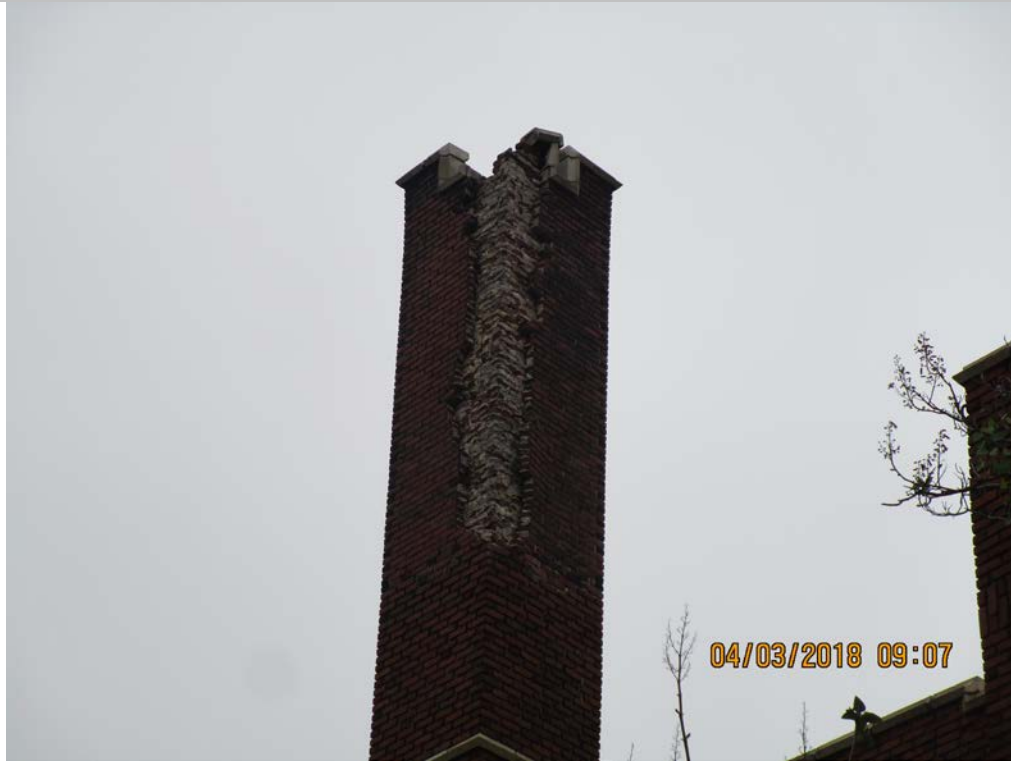
PHOTO 41

Exterior brick distress – cracking and collapse at top of boiler chimney.

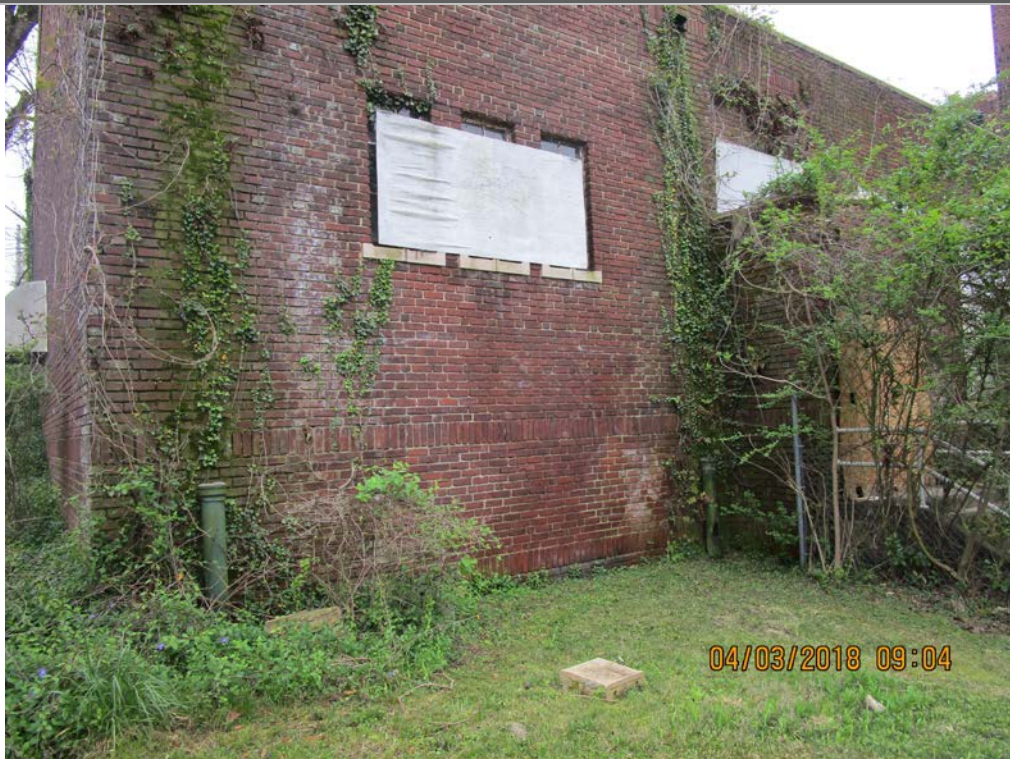
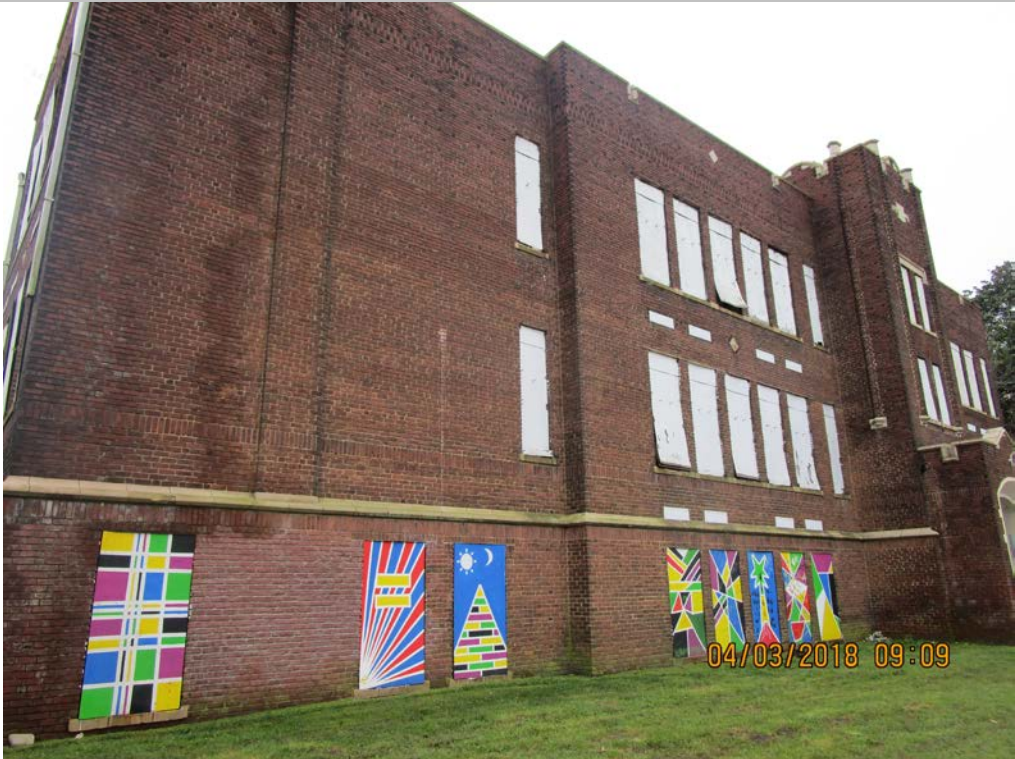
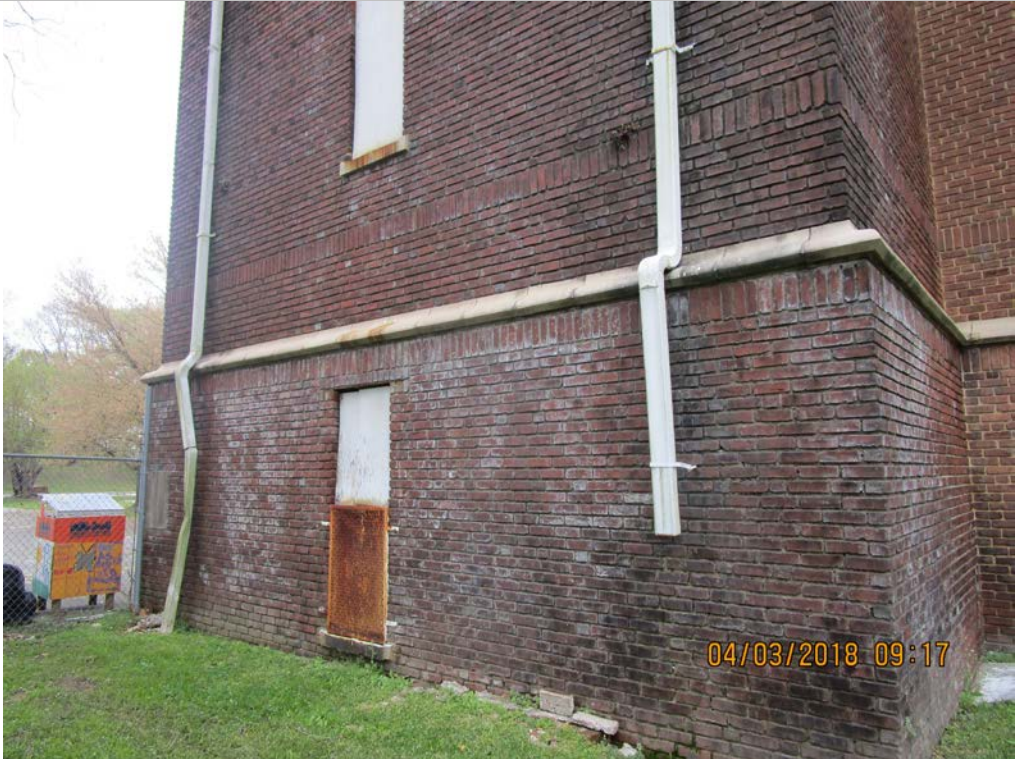
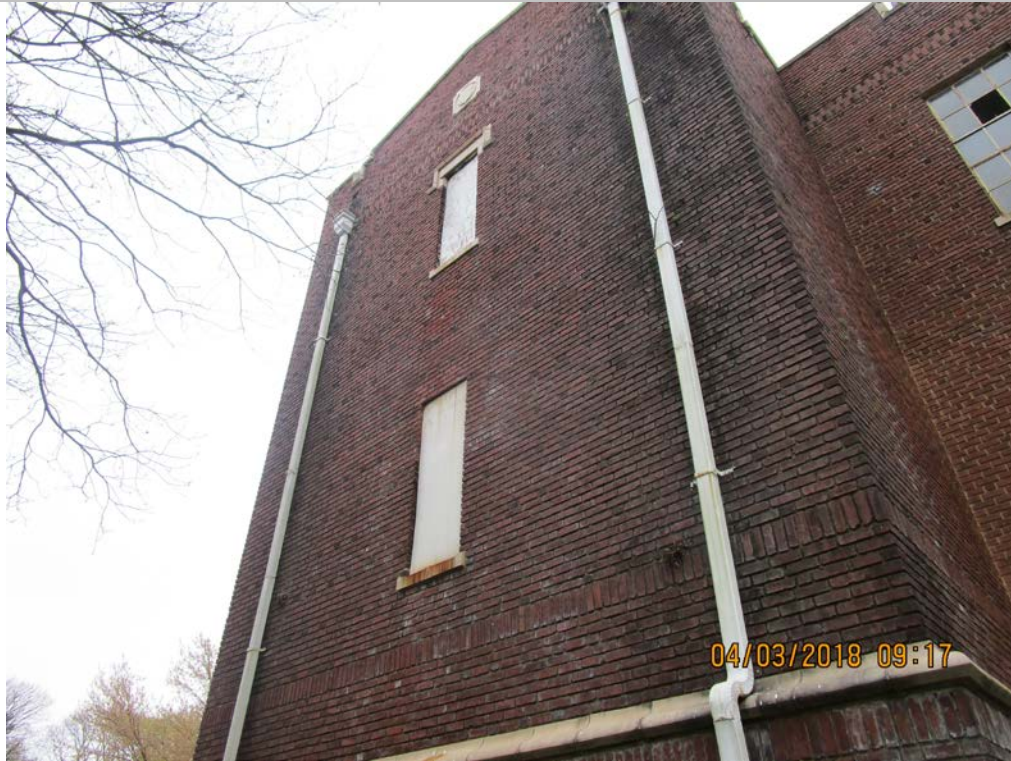
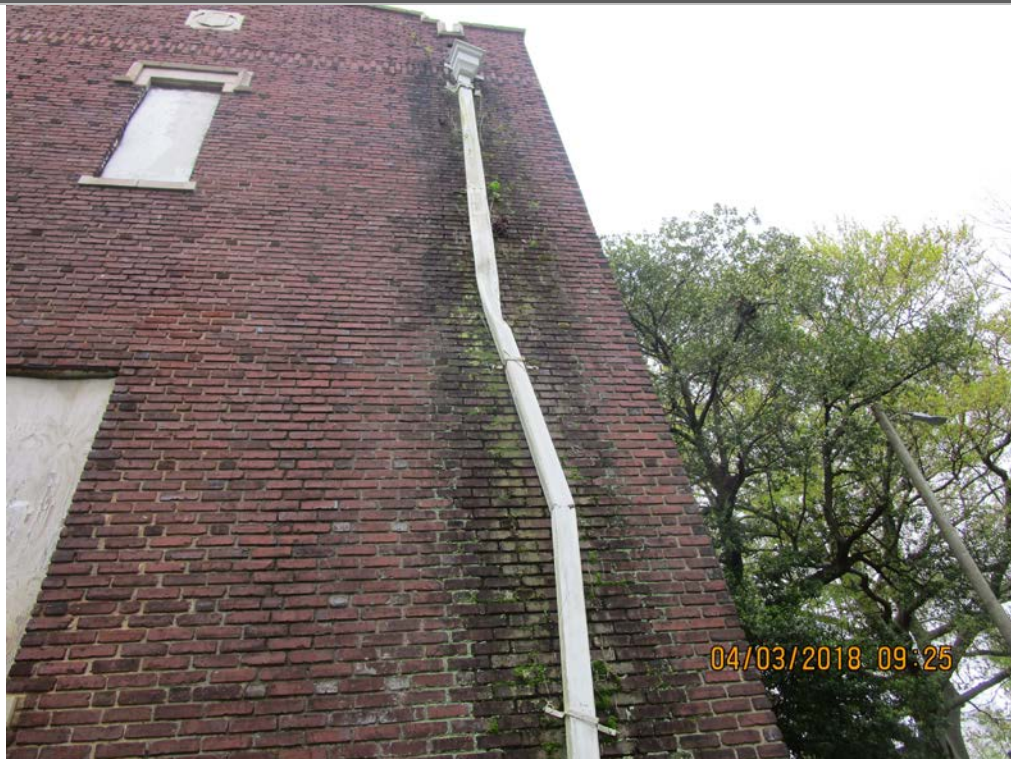
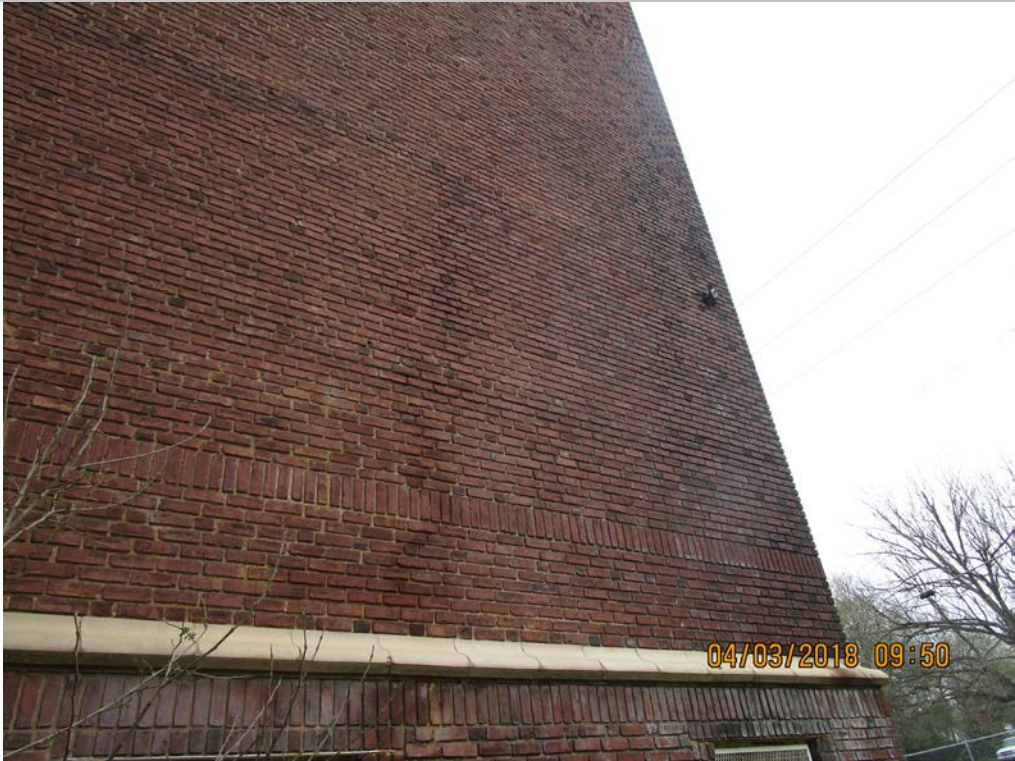
There are a number of areas where the exterior brick surface has been affected by water draining from the roof. Severe water stains are present, primarily around roof scuppers and downspouts. In some locations, water is entering into the cavity of the brick wythes and is leaching out through the brick mortar (*Photos 44-49*).

Exterior brick distress – water staining.

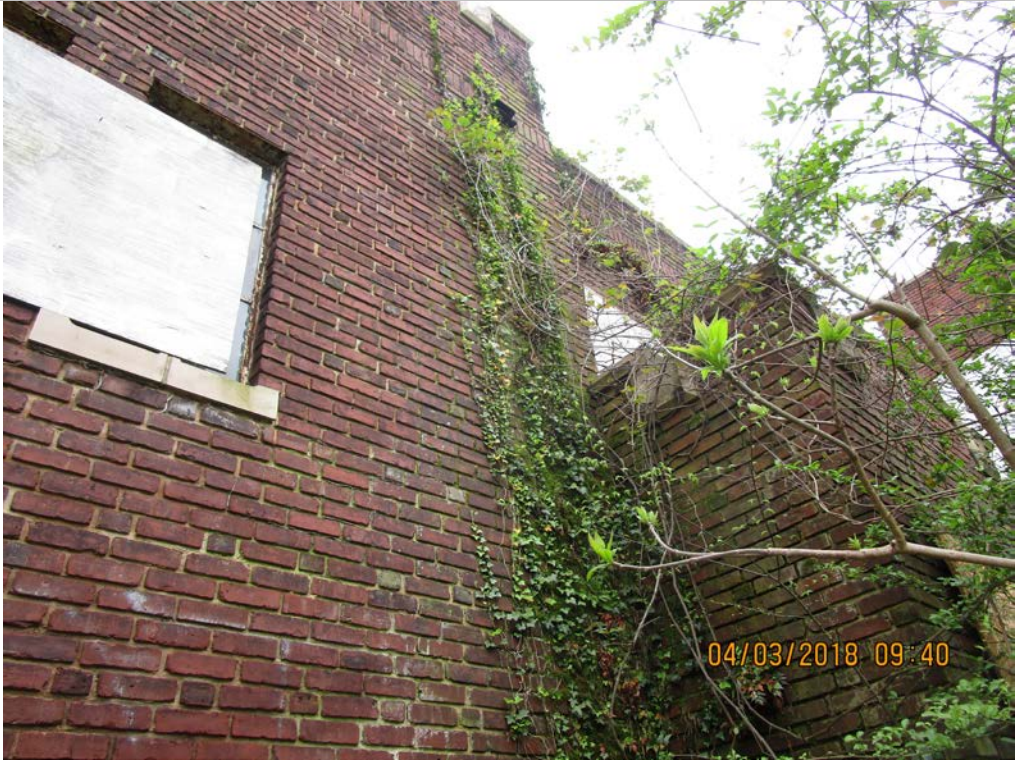
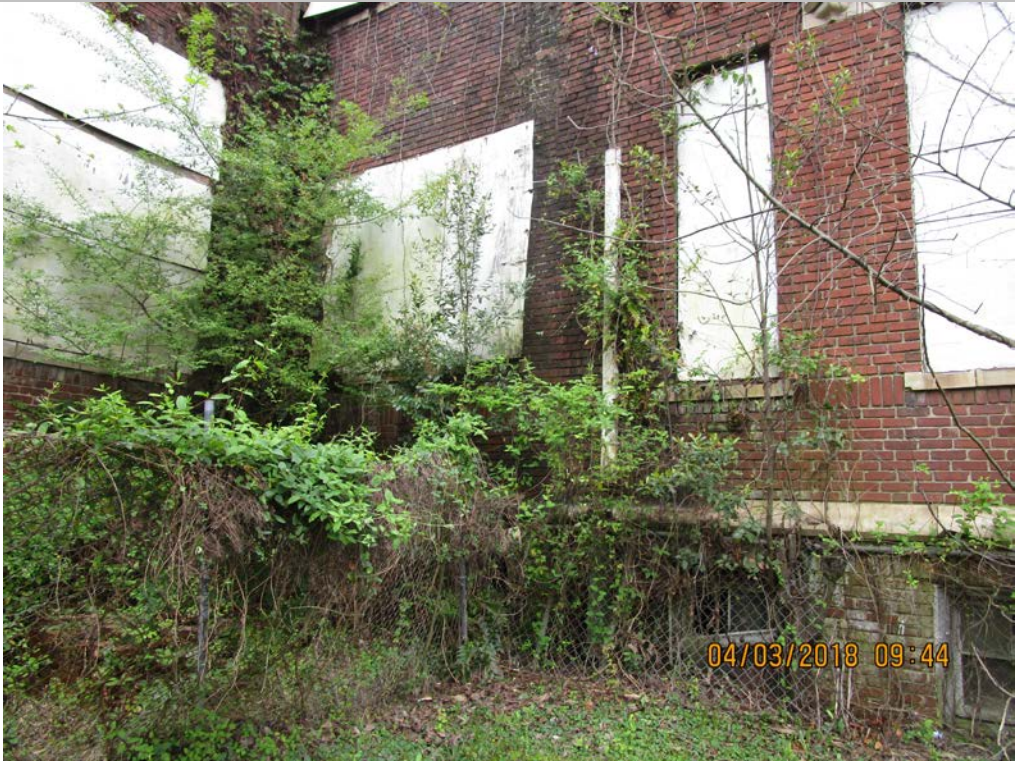
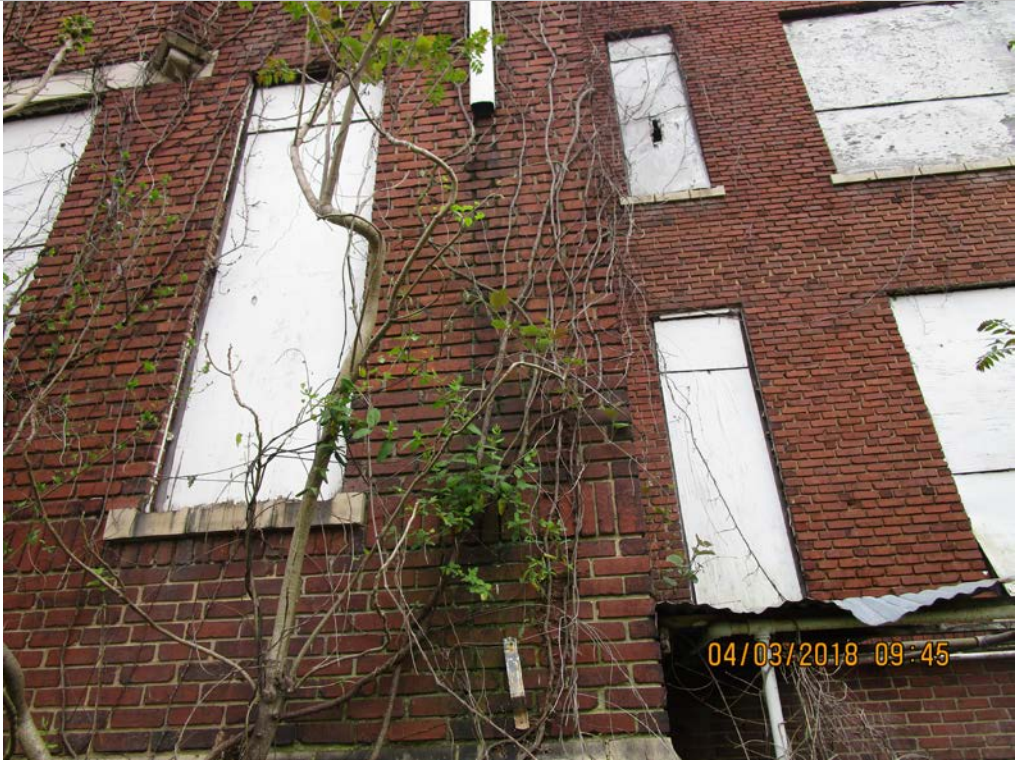
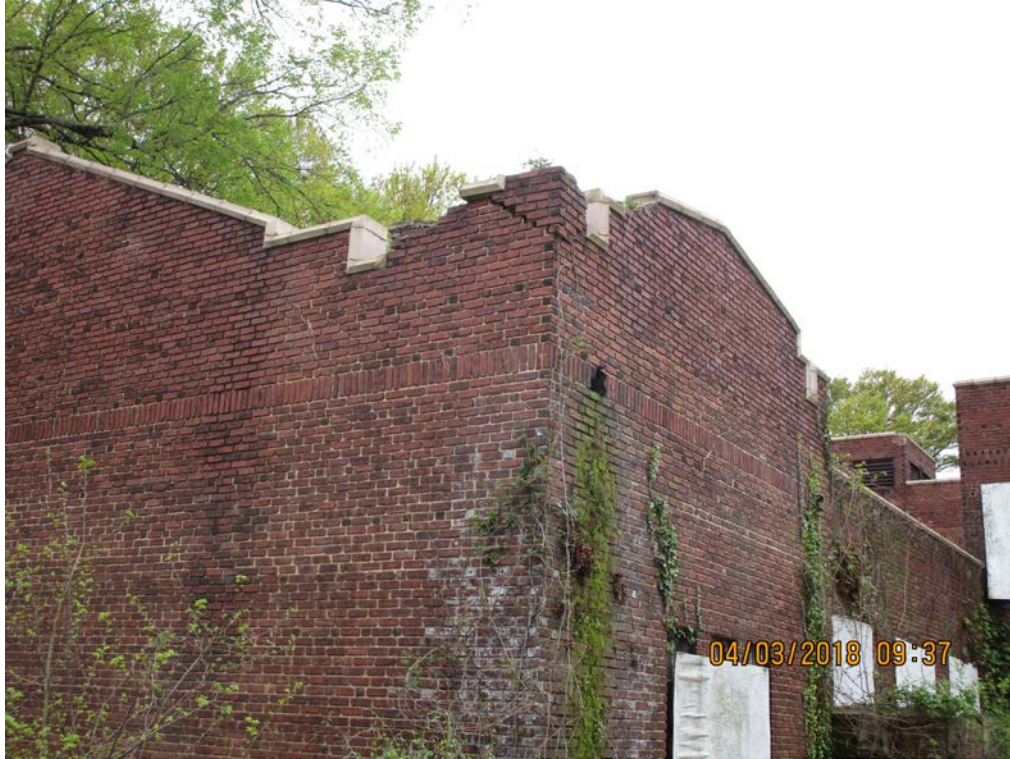
Vegetation in the form of vines is growing on the surface of some of the exterior brick. In some areas, the vines have grown through the brick and are visible from the interior of the building. There are also areas where trees have started to grow on top

Vegetation growing up building envelope.

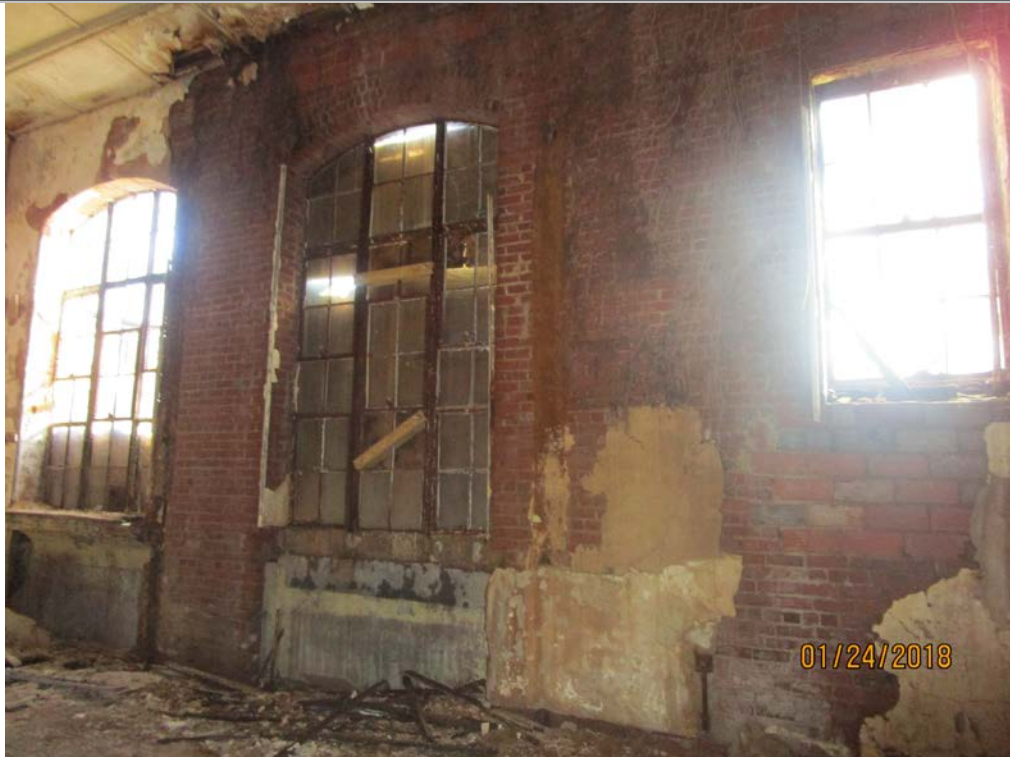
PHOTO 54

Vegetation growing through building envelope.

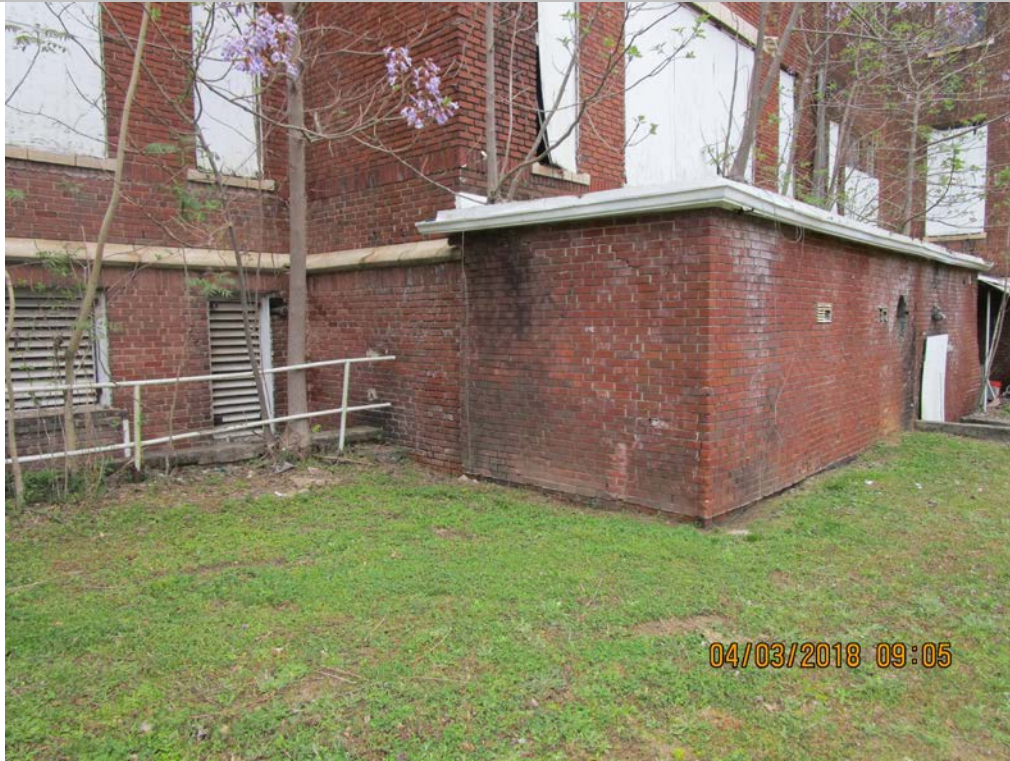
PHOTO 55

of the lower roofs (*Photos 50-55*). Satellite imaging shows areas of possible vegetation growth on the main roof sections that have not collapsed.

Vegetation growing on top of roof.

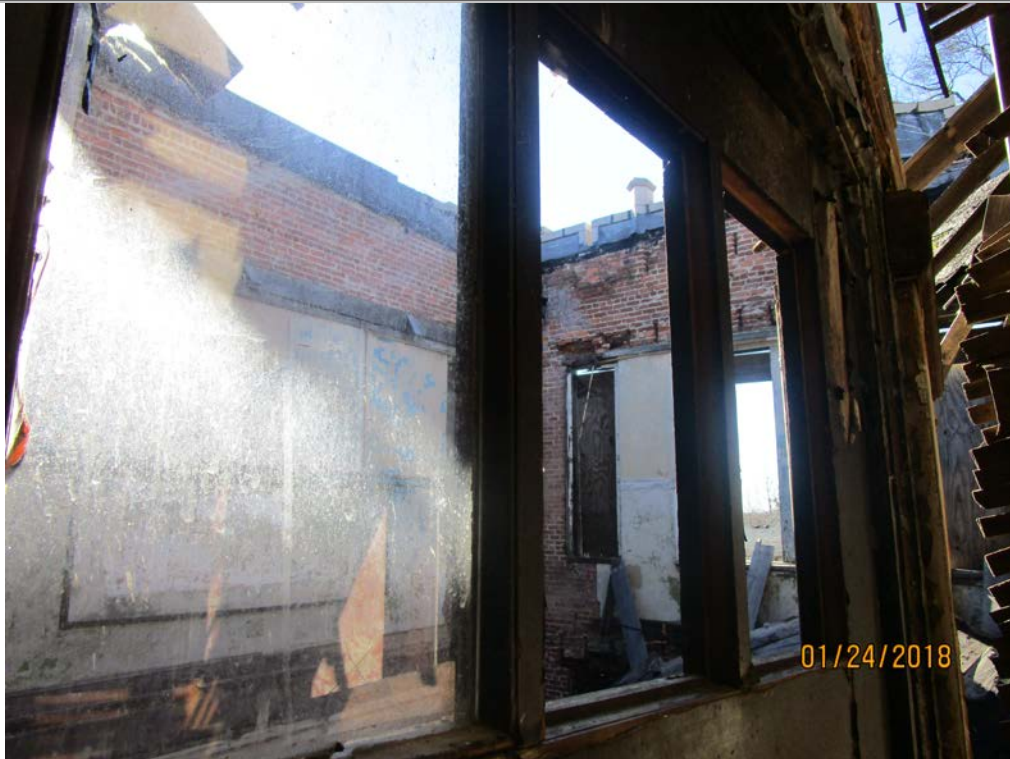
PHOTO 56

D. **Roof Assessment.** The roof consists of wood framing in the area of the original building and auditorium. Additionally, based on satellite imaging, the roof covering over the atrium areas consists of metal roofing. The wood roof framing is in very poor condition. In some areas, the roof has completely collapsed due to wood rot (*Photo 56*).

Roof framing collapsed.

All roof systems constructed with wood are severely deteriorated and require complete removal and replacement.

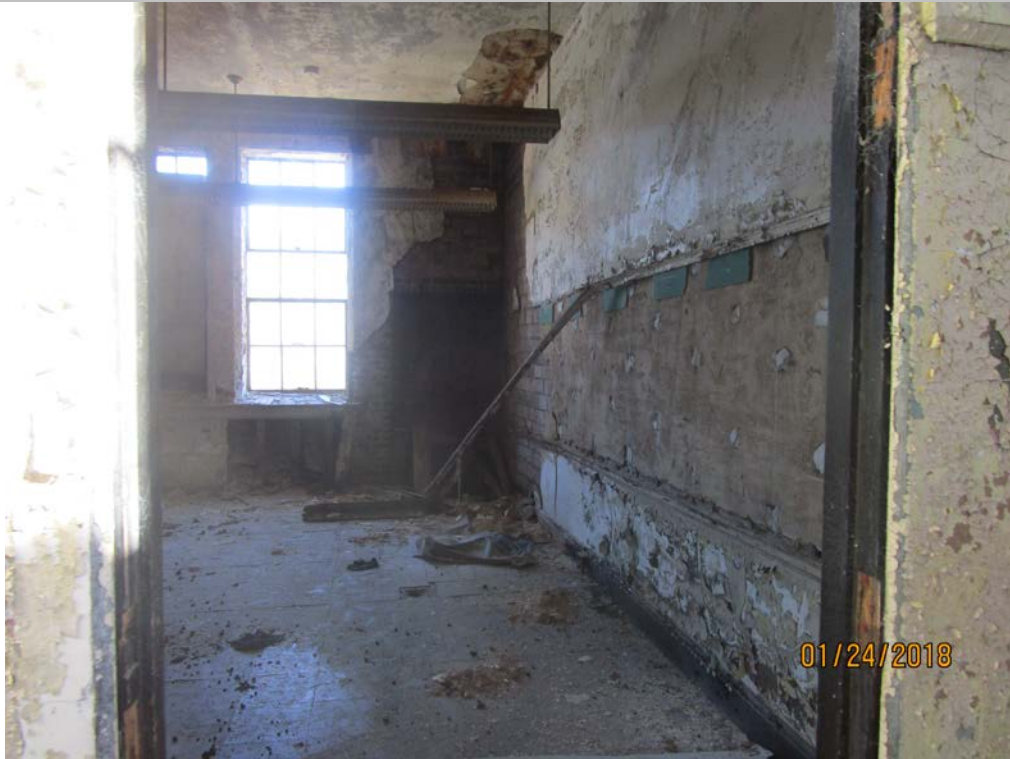
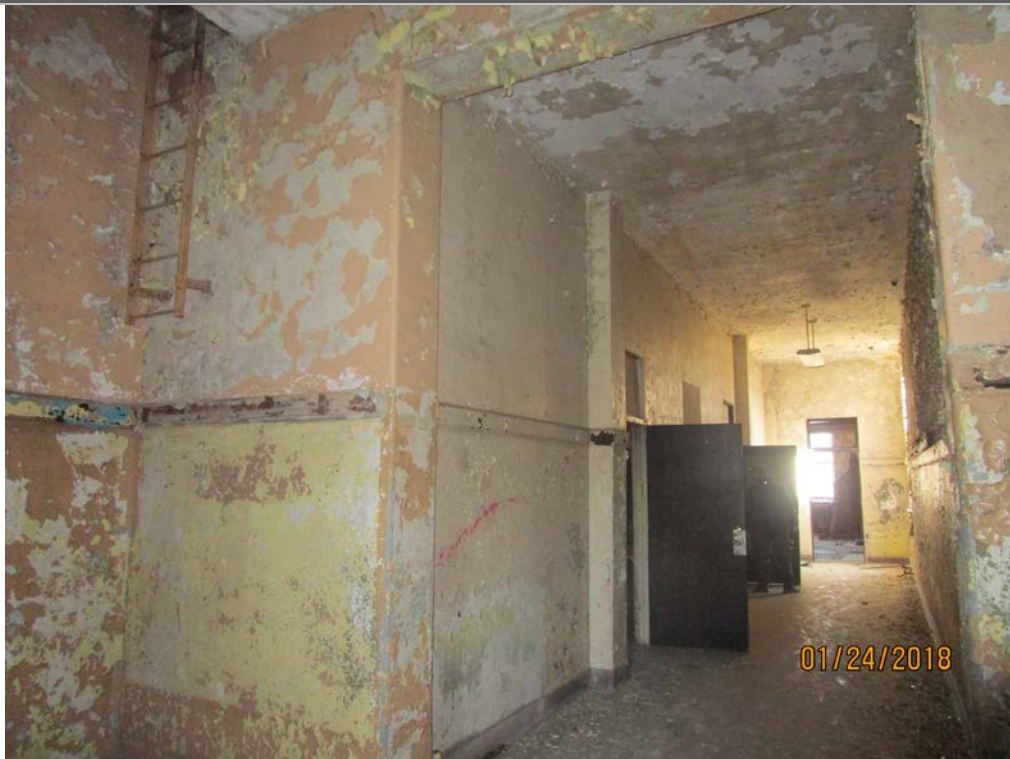
The left and right side wings roof system could not be properly verified as it remains covered with a plaster coating. However, it looks as if the roof construction consists of formed and poured concrete similar to that of the floor systems in this area (*Photos 57 and 58*). Additionally, in one location, terracotta brick can be seen where some of the plaster has fallen off.

Roof system of left and right wing additions covered with plaster – further evaluation needed.

Further evaluation of the roof systems in these areas is required in order to properly verify the roof construction.
